Efectis Nederland report**2008-Efectis-R1046****Investigation of concrete cracking due to fire in
scaled immersed tunnel elements**

Date April 2009

An investigation of fire in immersed scaled tunnel elements.

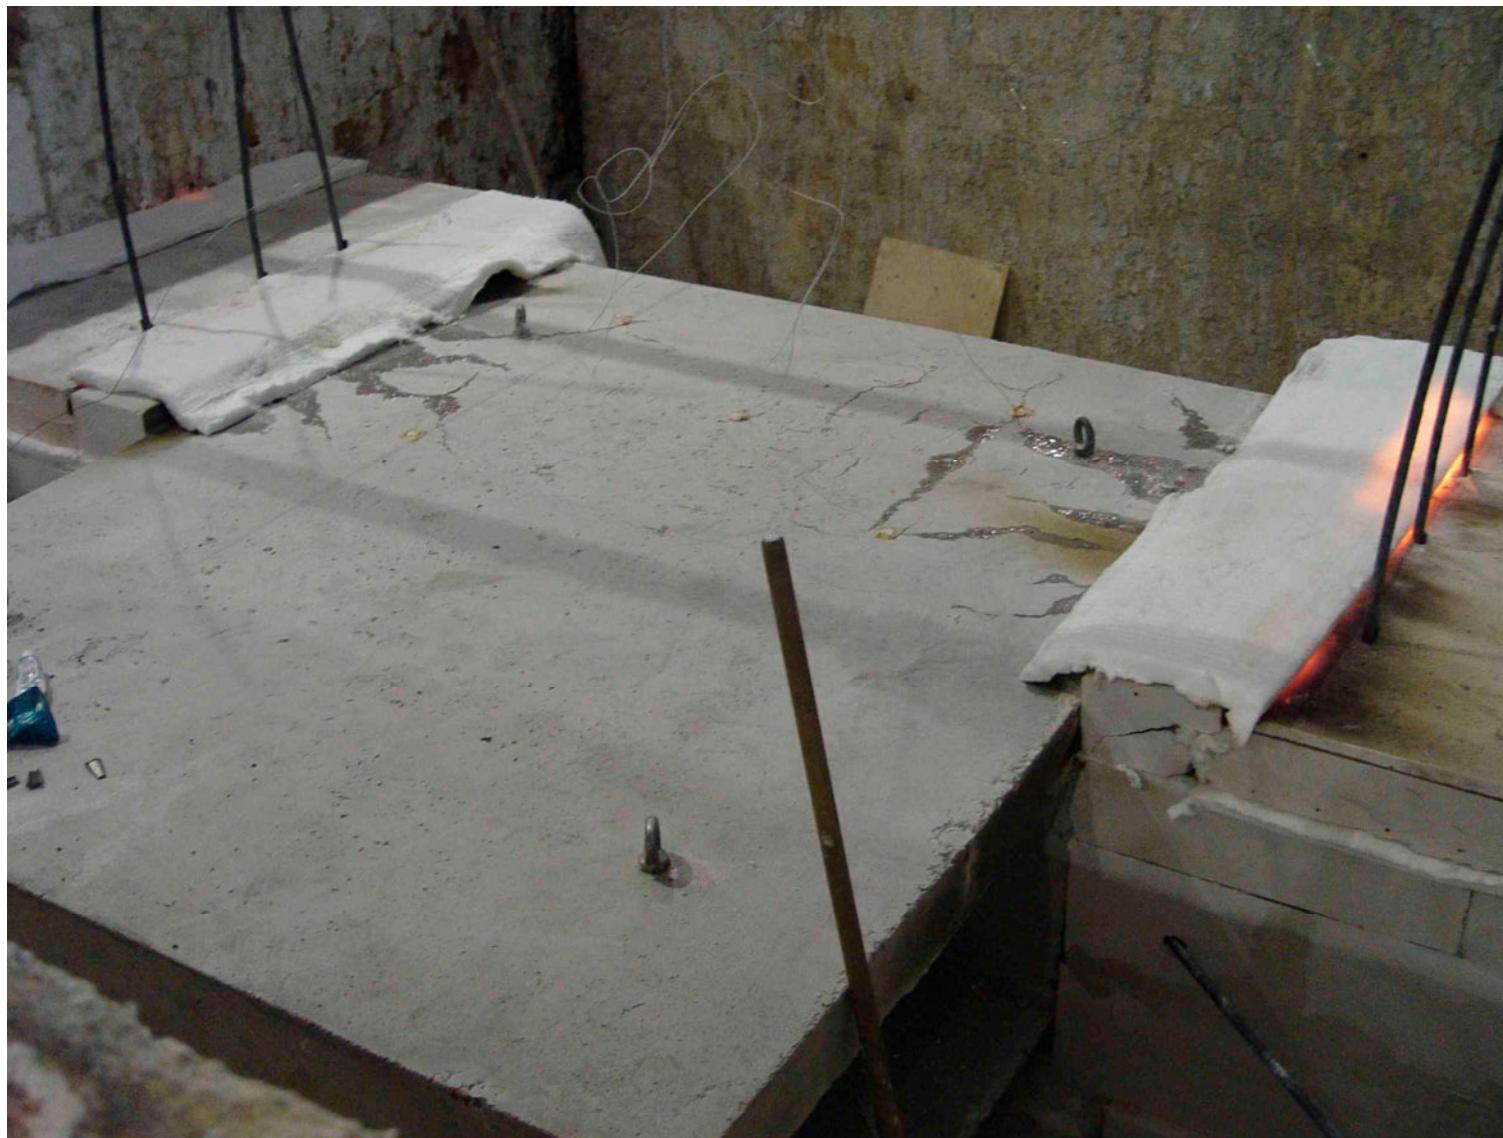
Figure A3 Element 0 after 10 minutes of heating

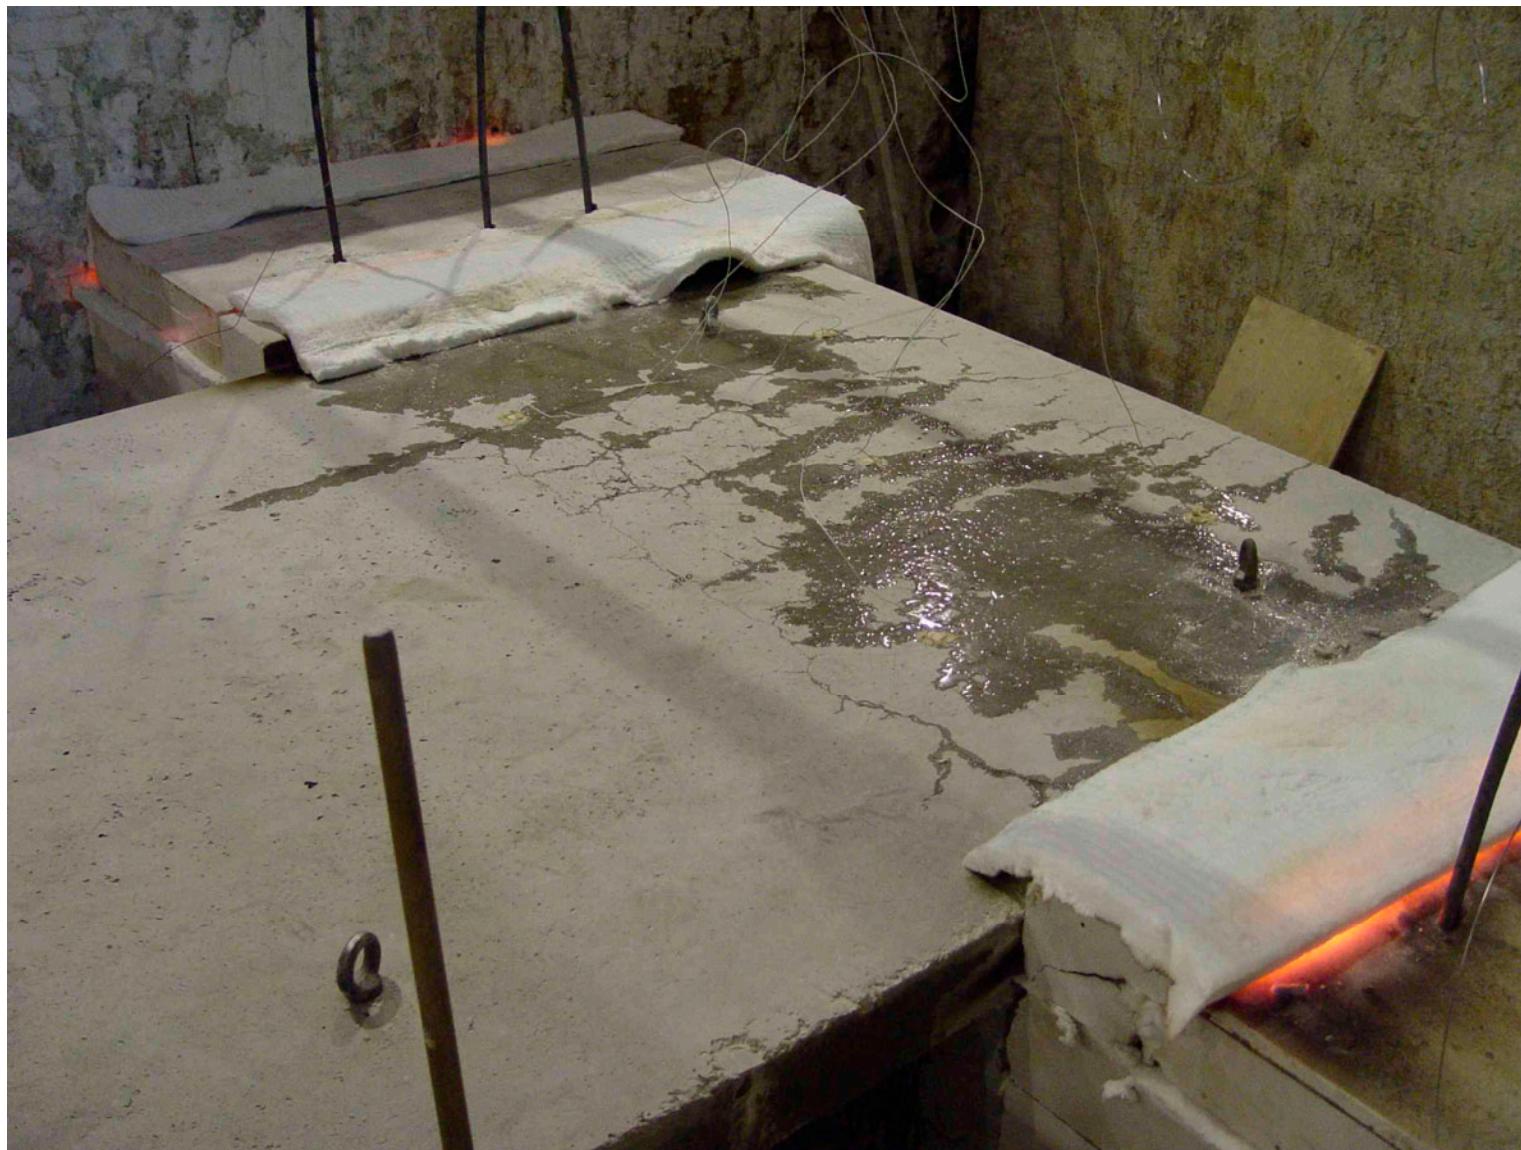
Figure A5 Element 0 after 14 minutes of heating

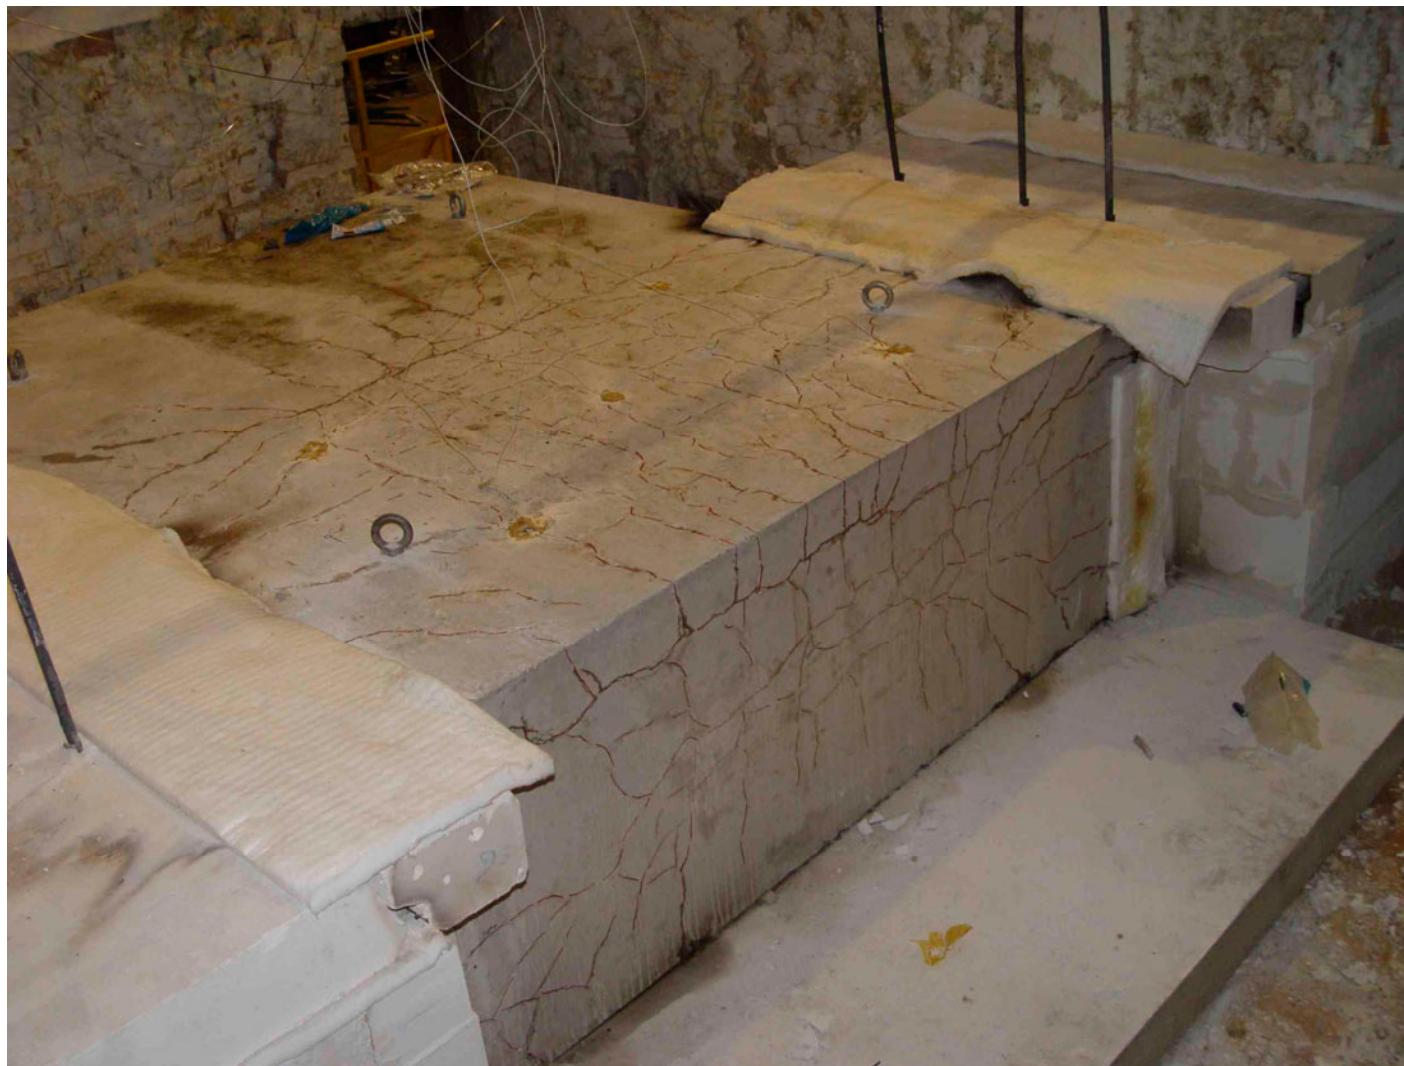
Figure A9 Element 0 cracking pattern on upper and side surface

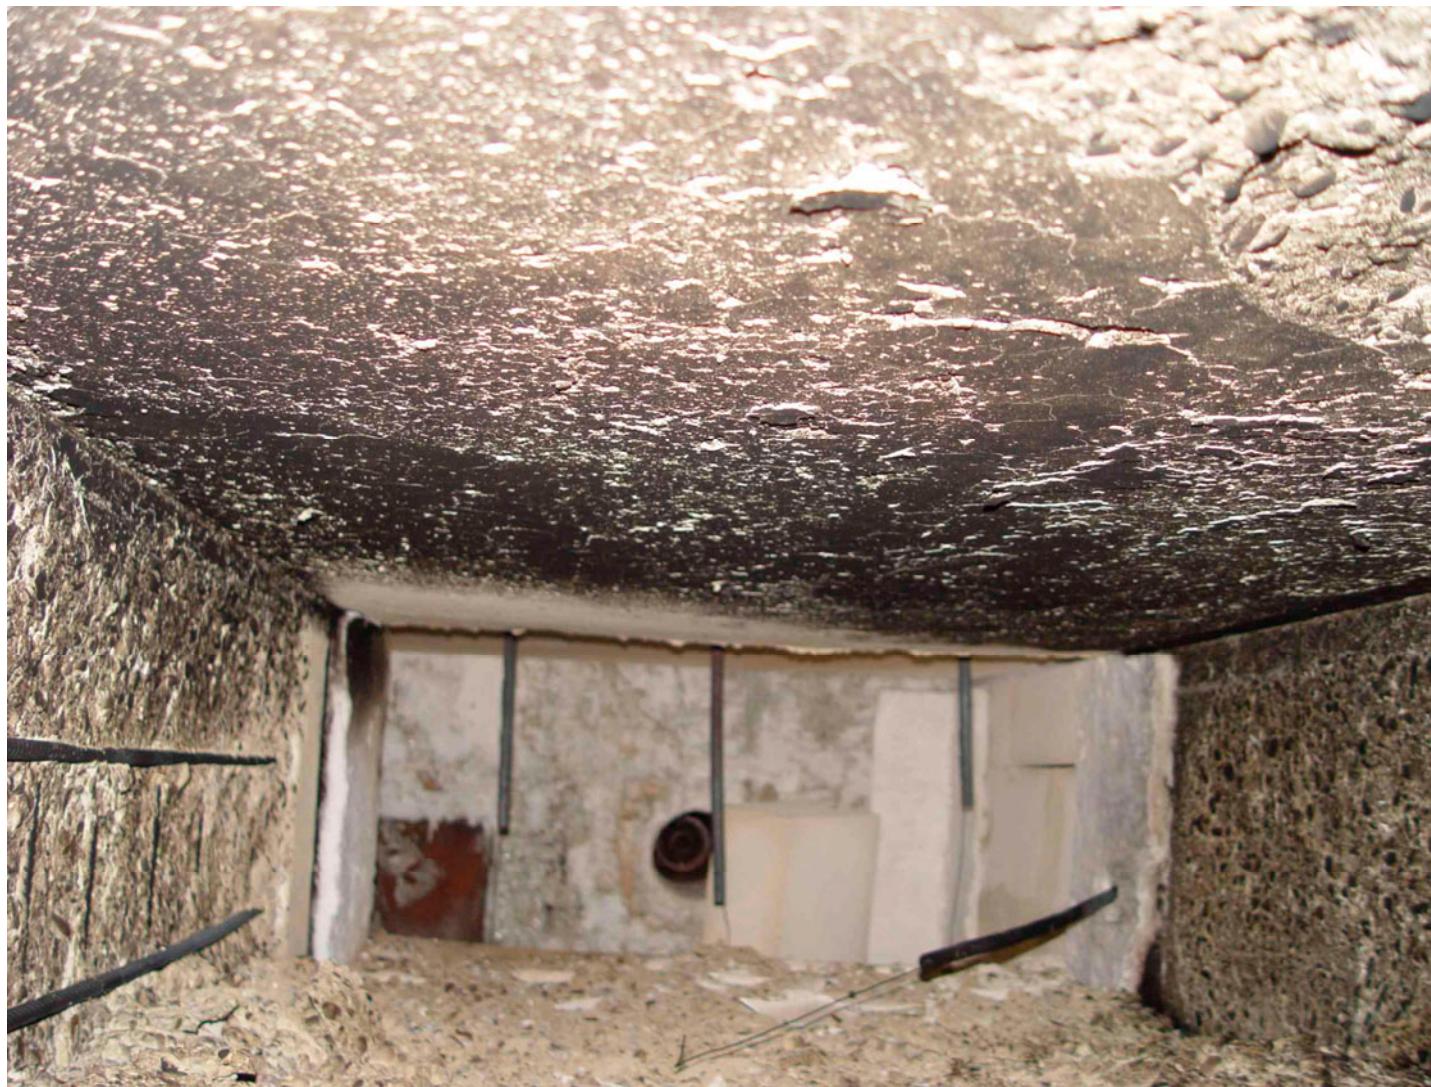
Figure A10 Element 0 spalling on the inside of the element

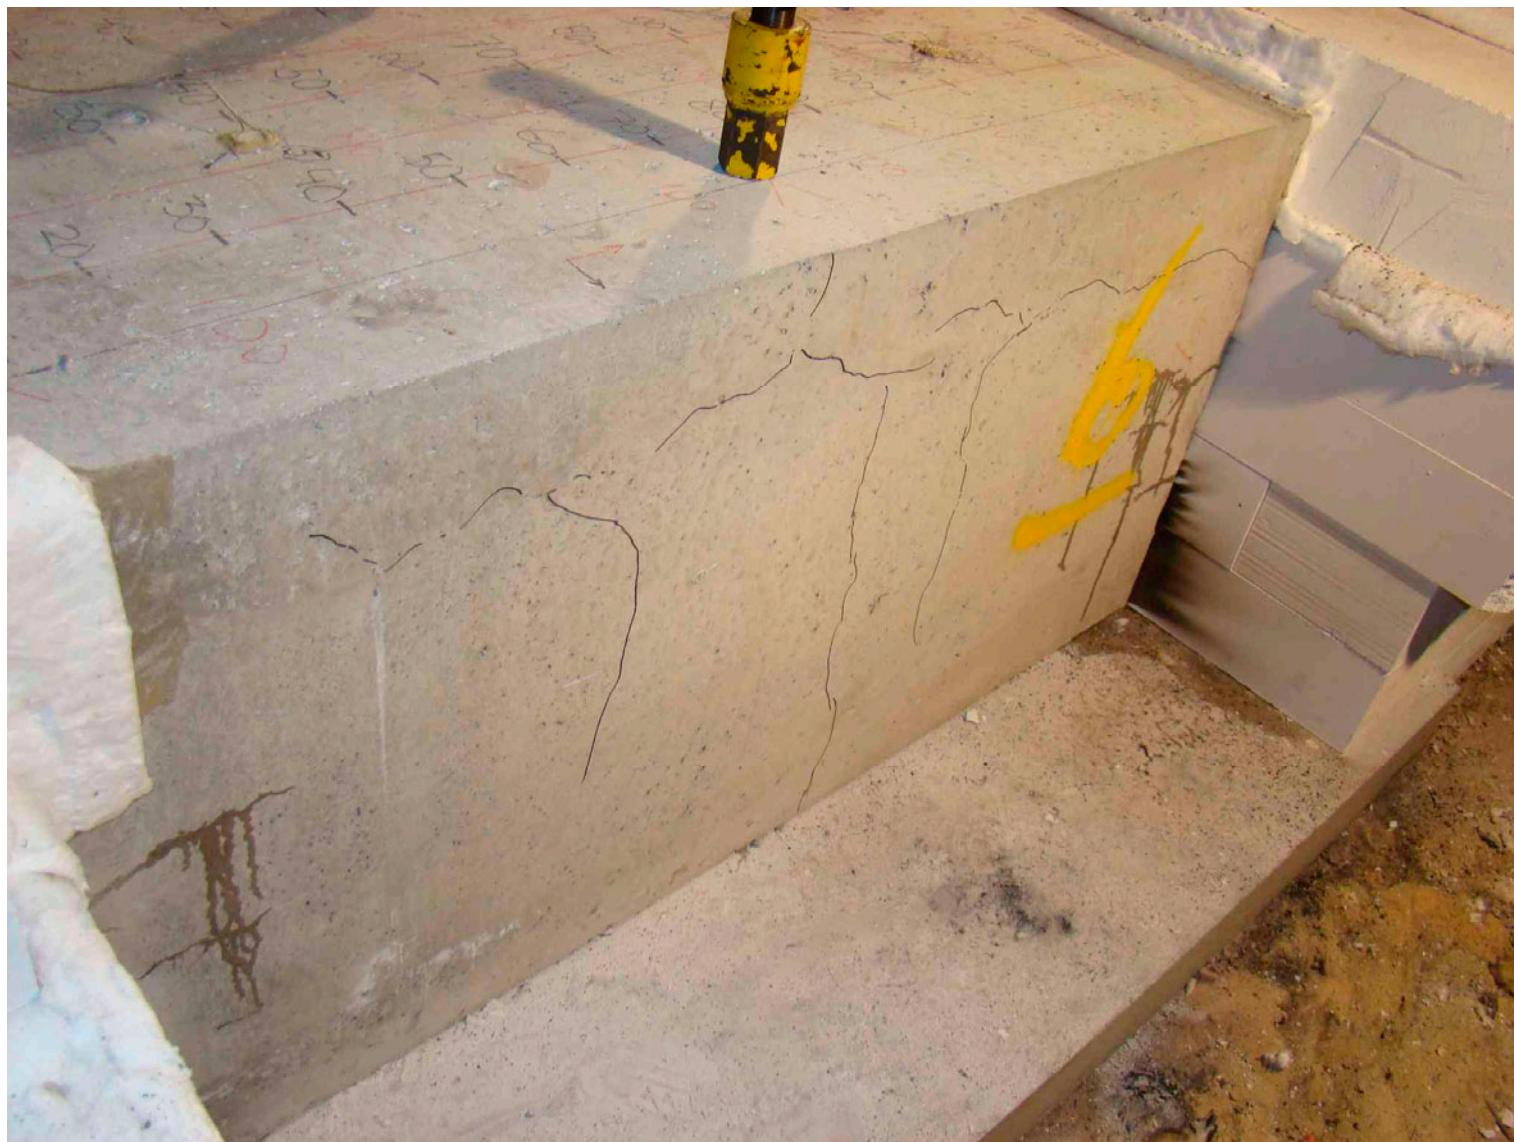
Figure B9 Element 6 after 14 minutes of heating

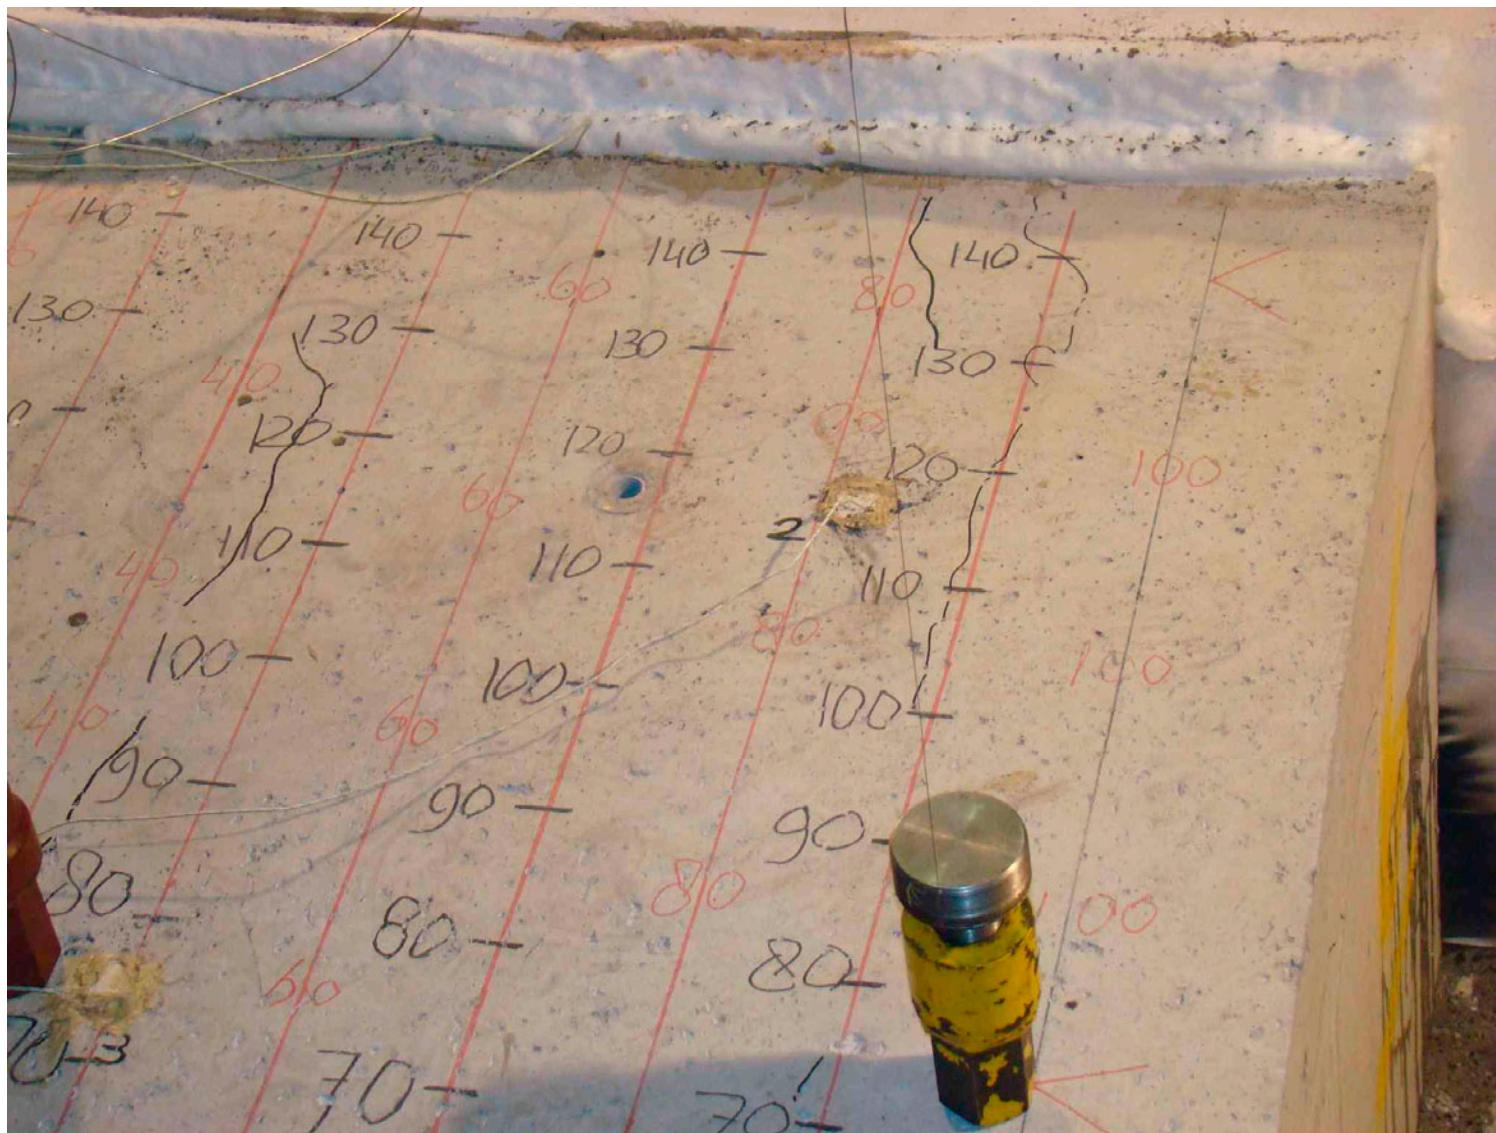
Figure B12 Element 6 after 21 minutes of heating, upper right corner detail

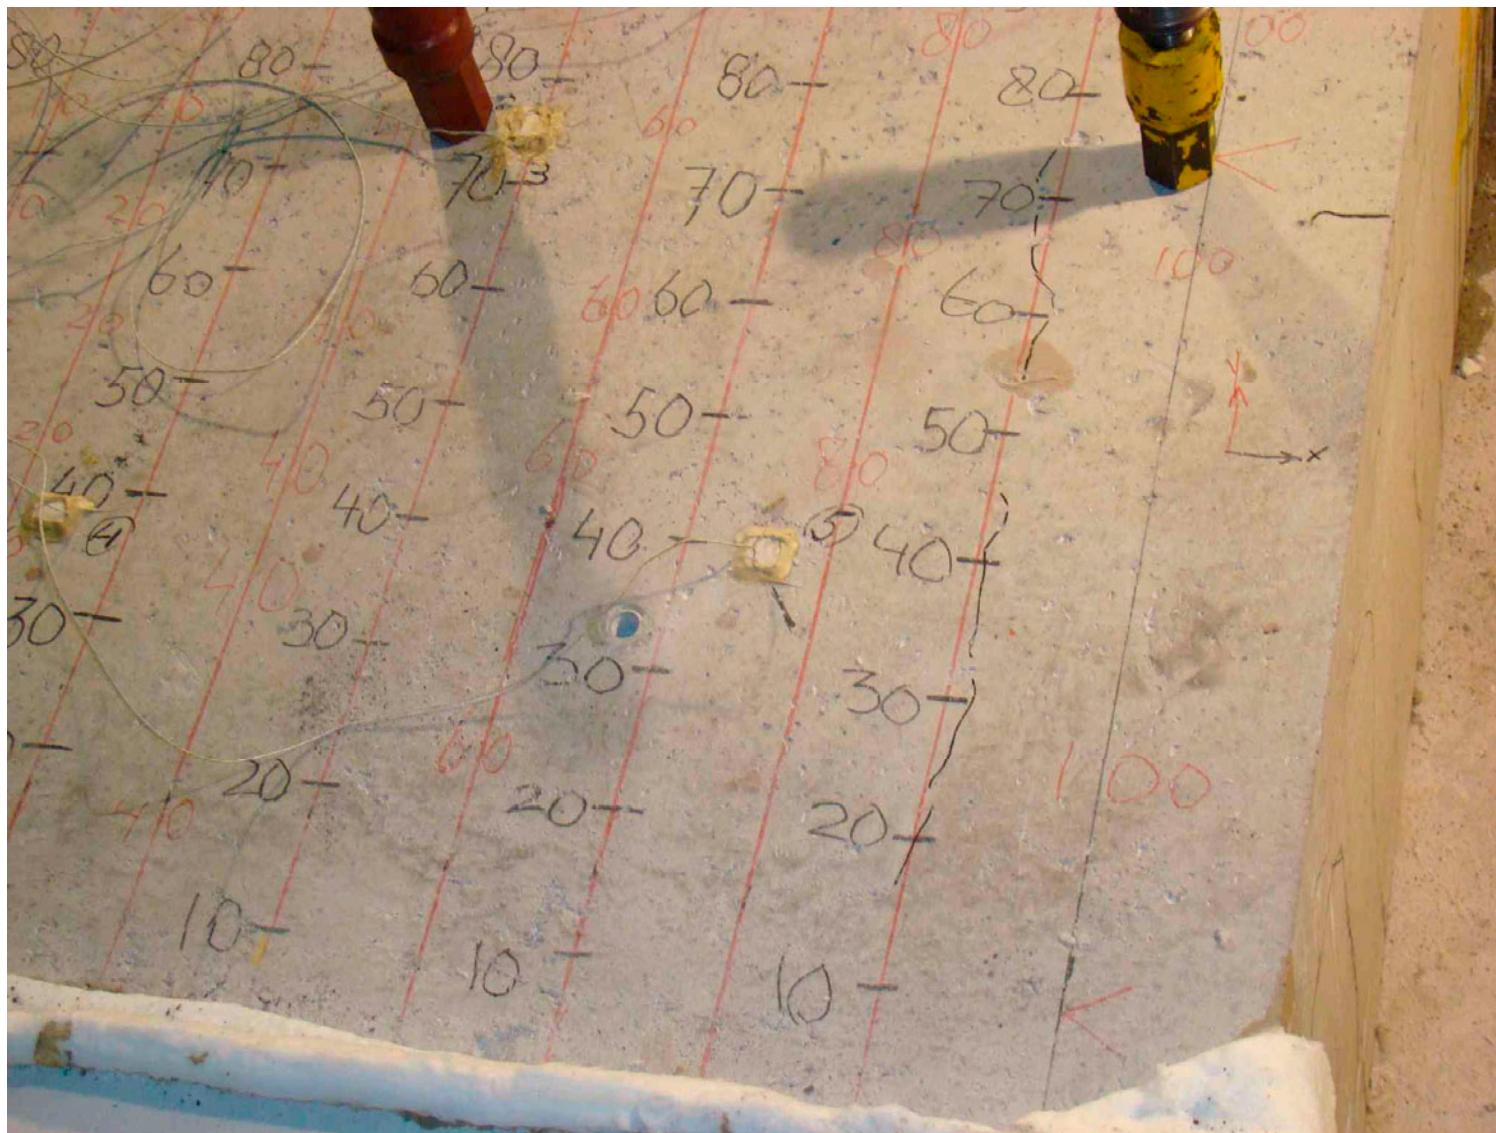
Figure B14 Element 6 after 21 minutes of heating, lower right corner detail

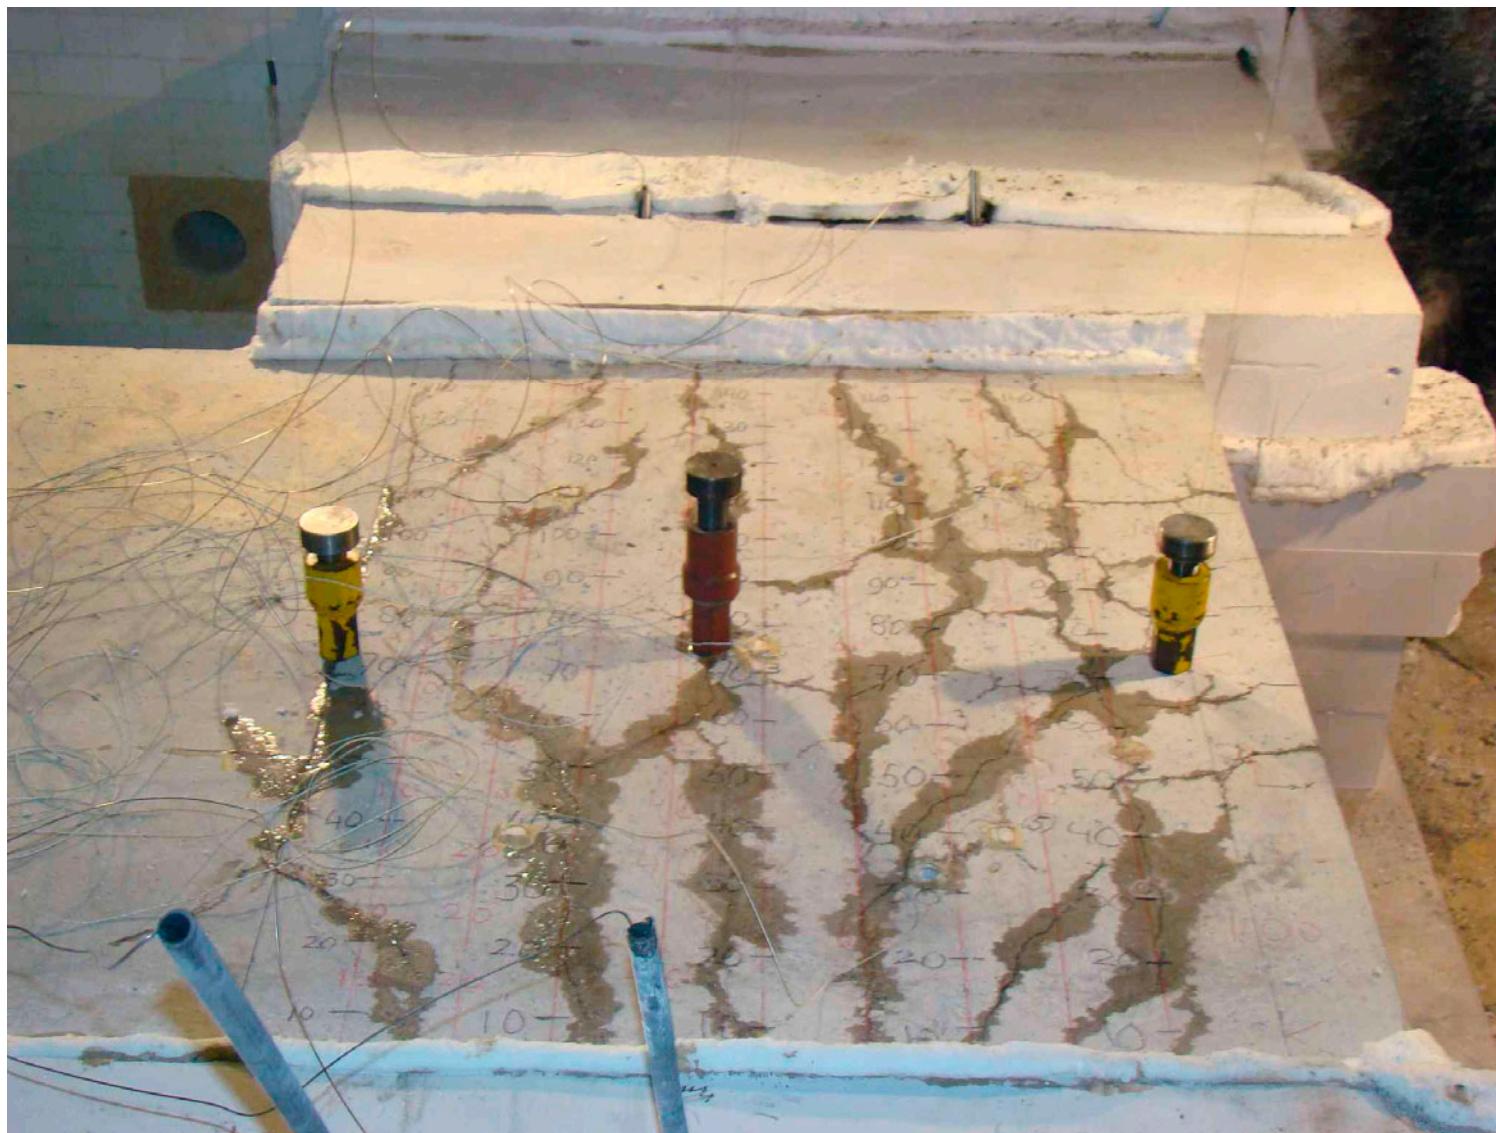
Figure B17 Element 6 after 99 minutes of heating

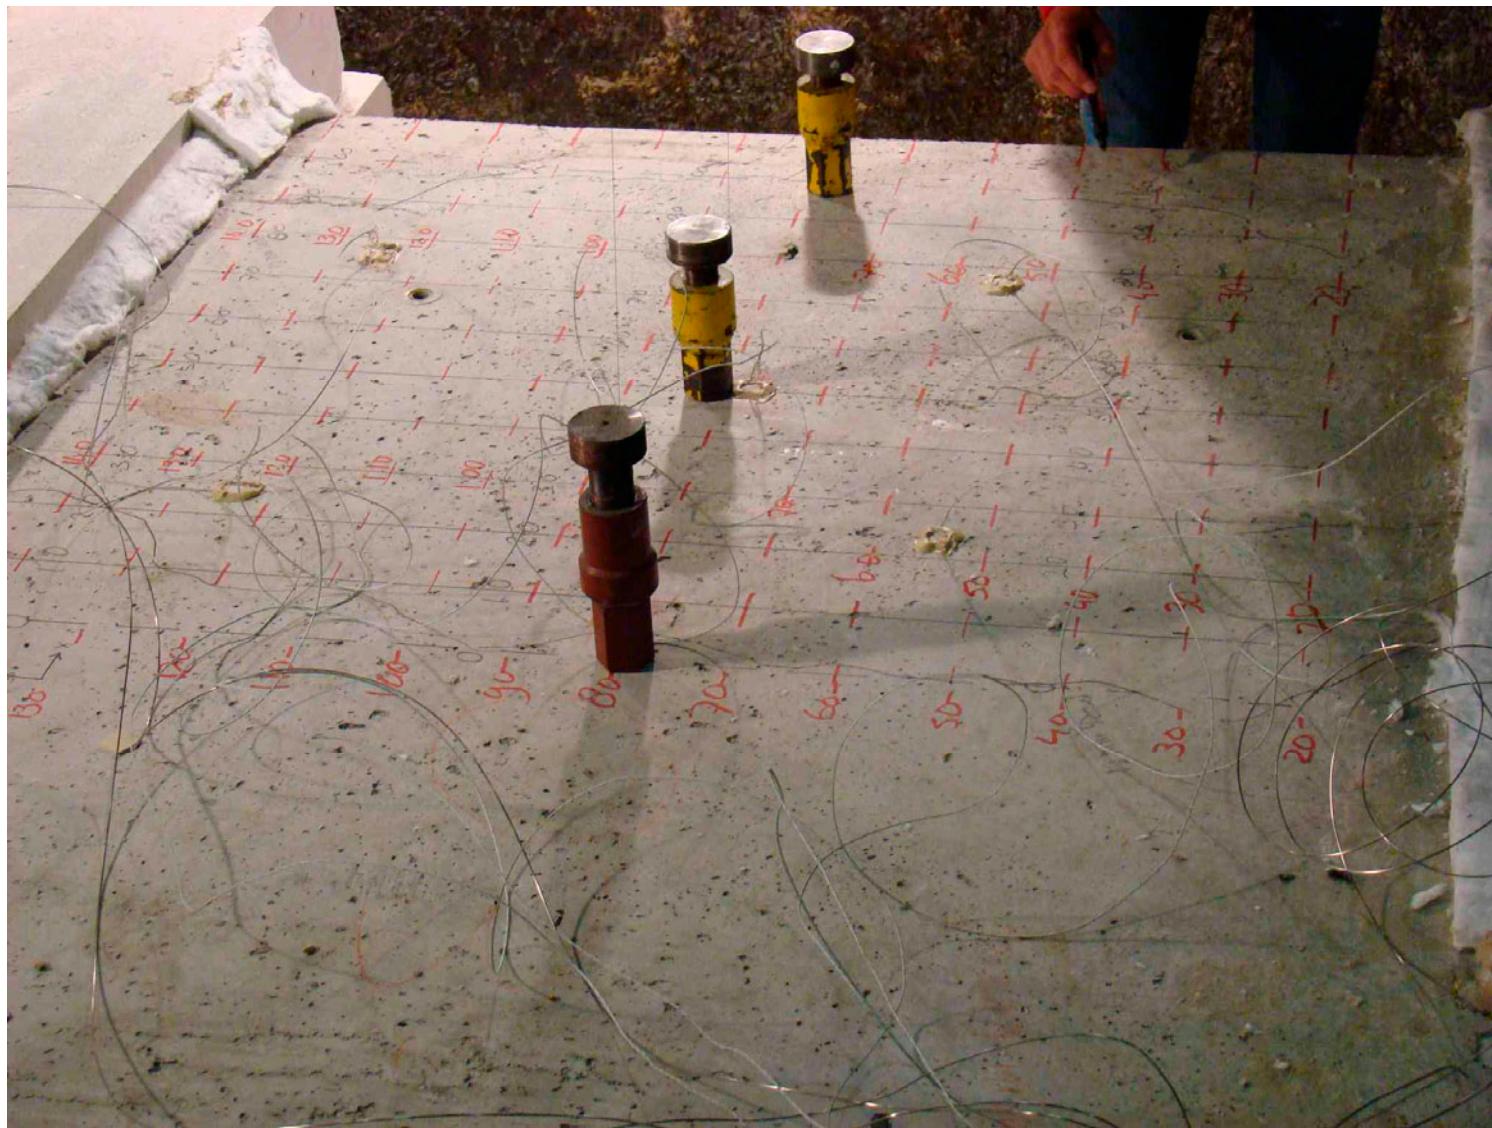
Figure D9 Element 8 after 15 minutes of heating

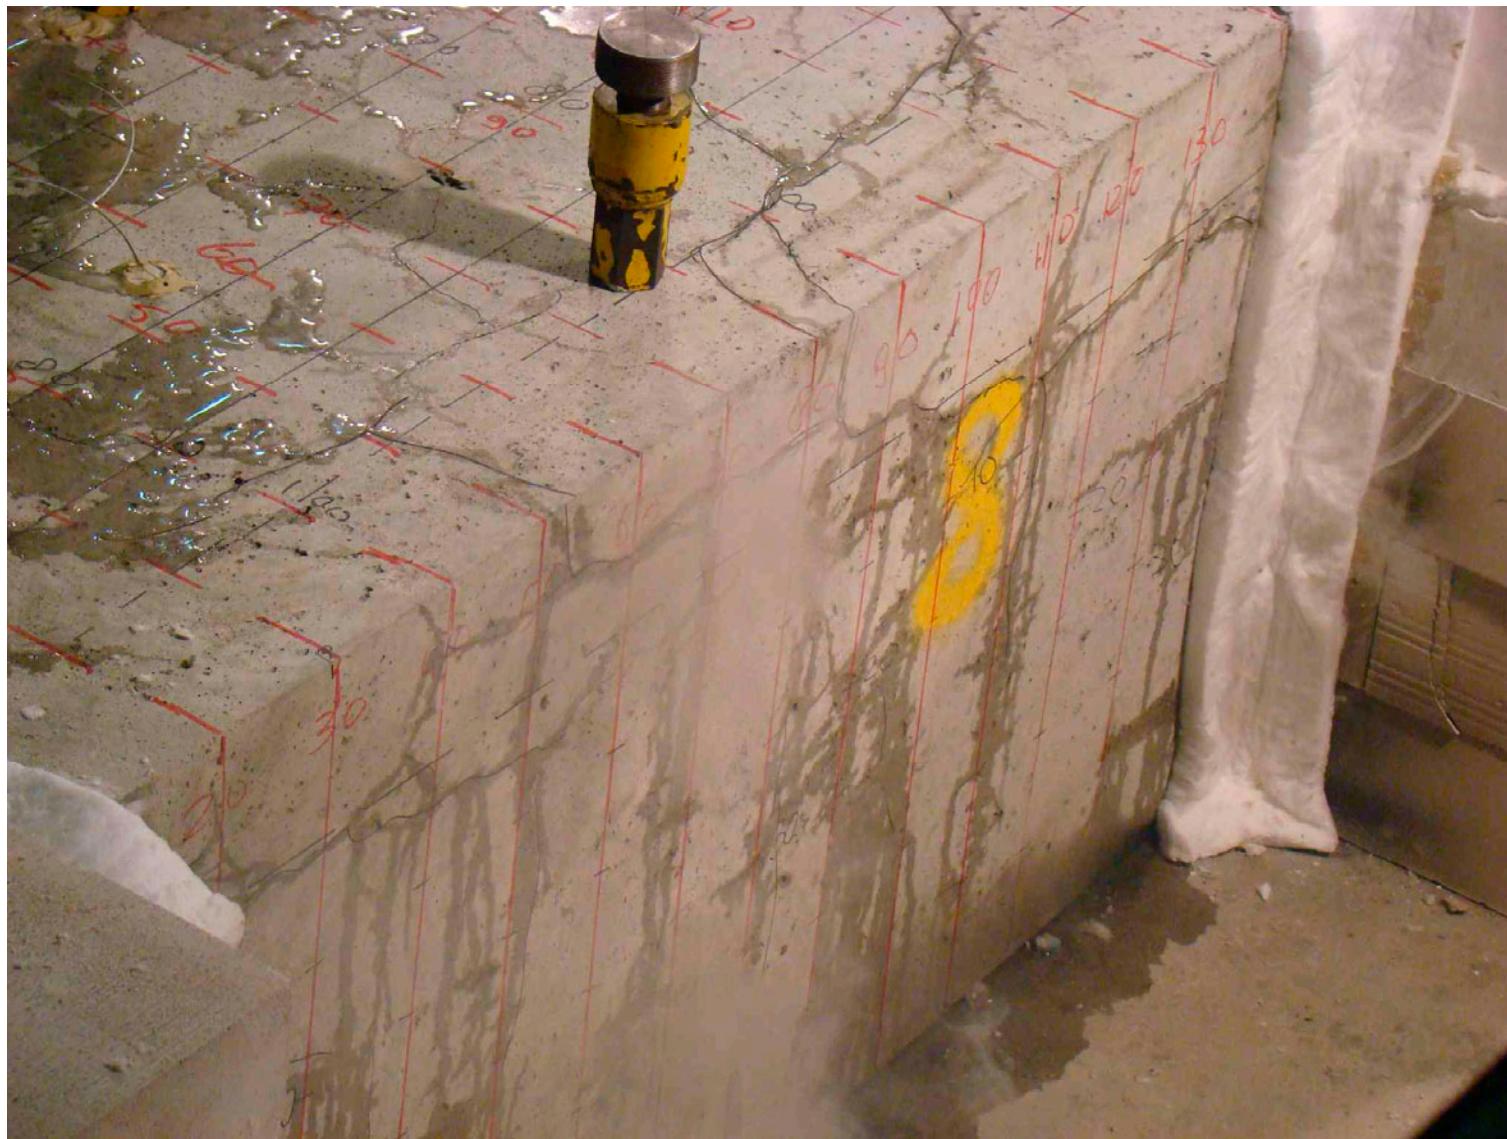
Figure D10 Element 8 after 29 minutes of heating

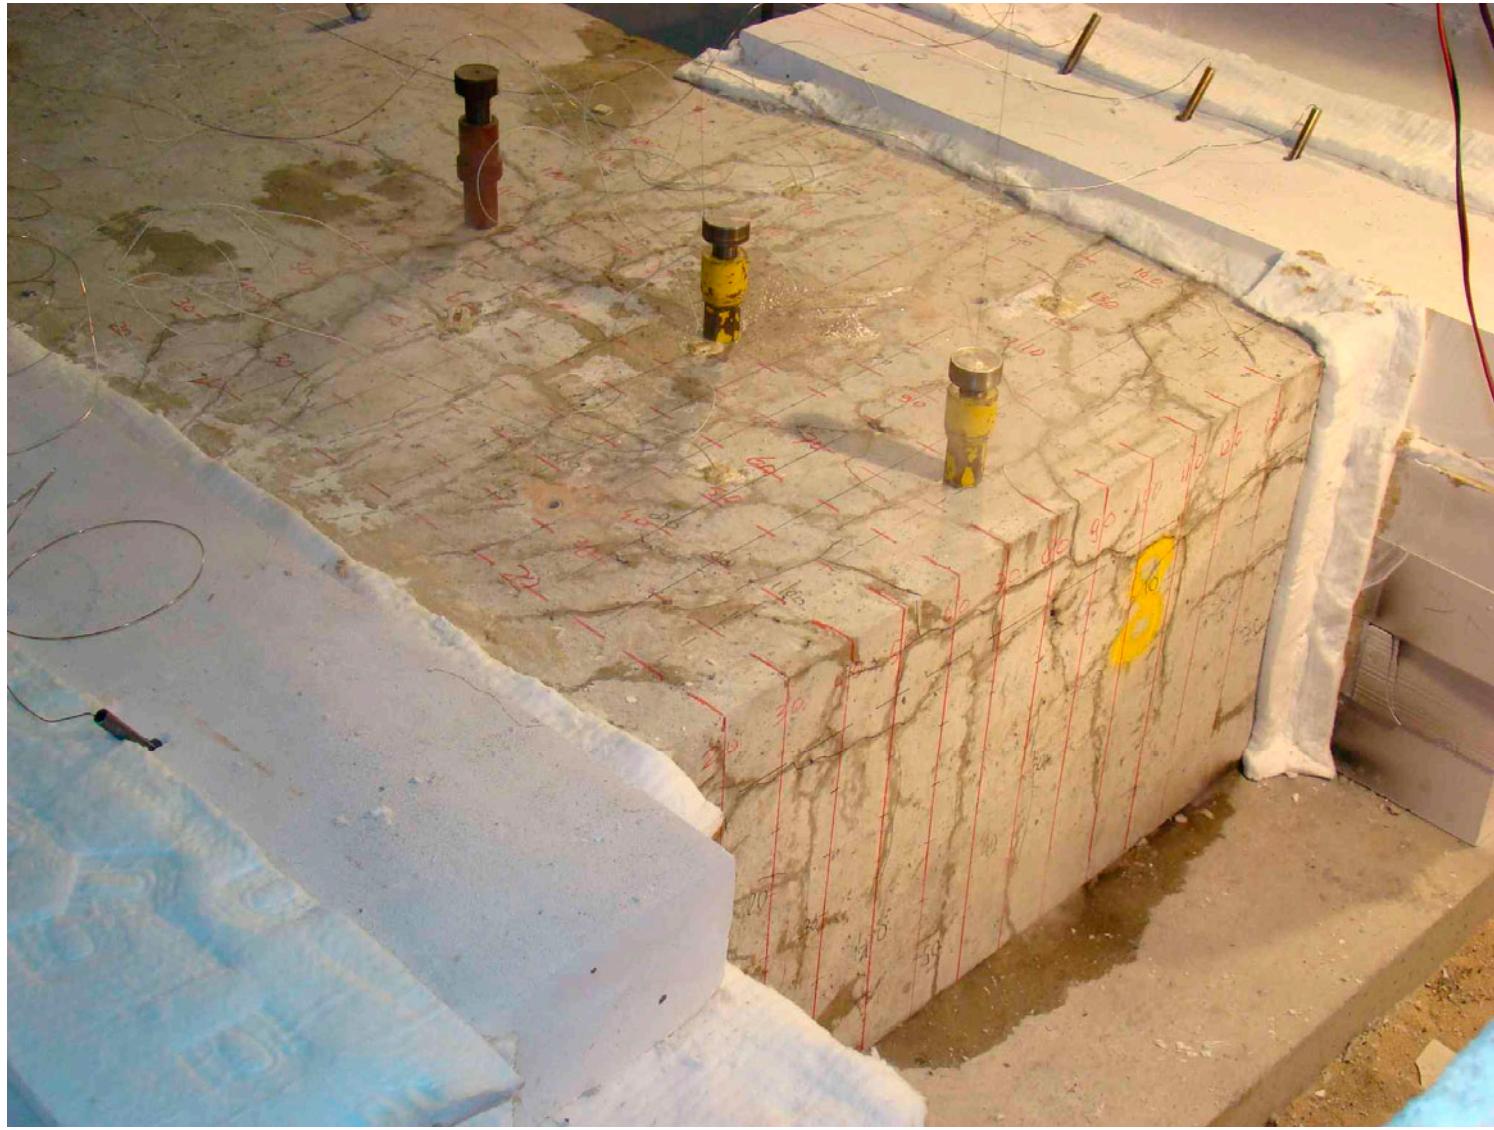
Figure D12 Element 8 ± 5 minutes after the fire test

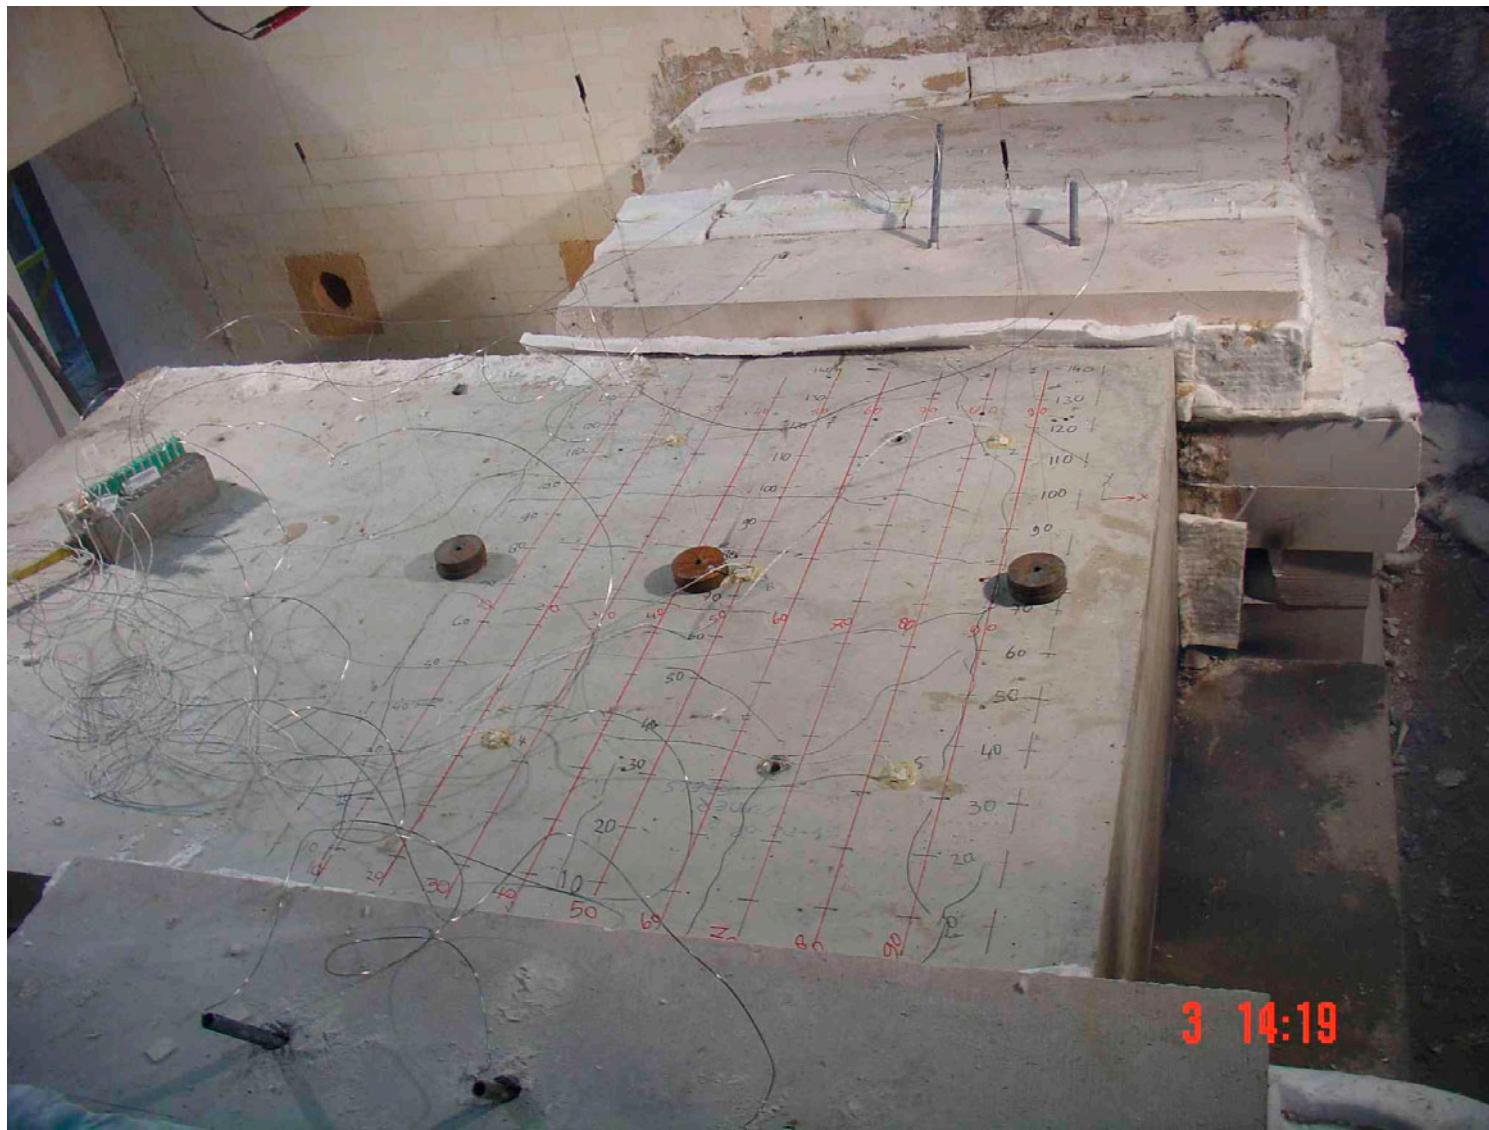
Figure F8 Element 2 after 9 minutes of heating

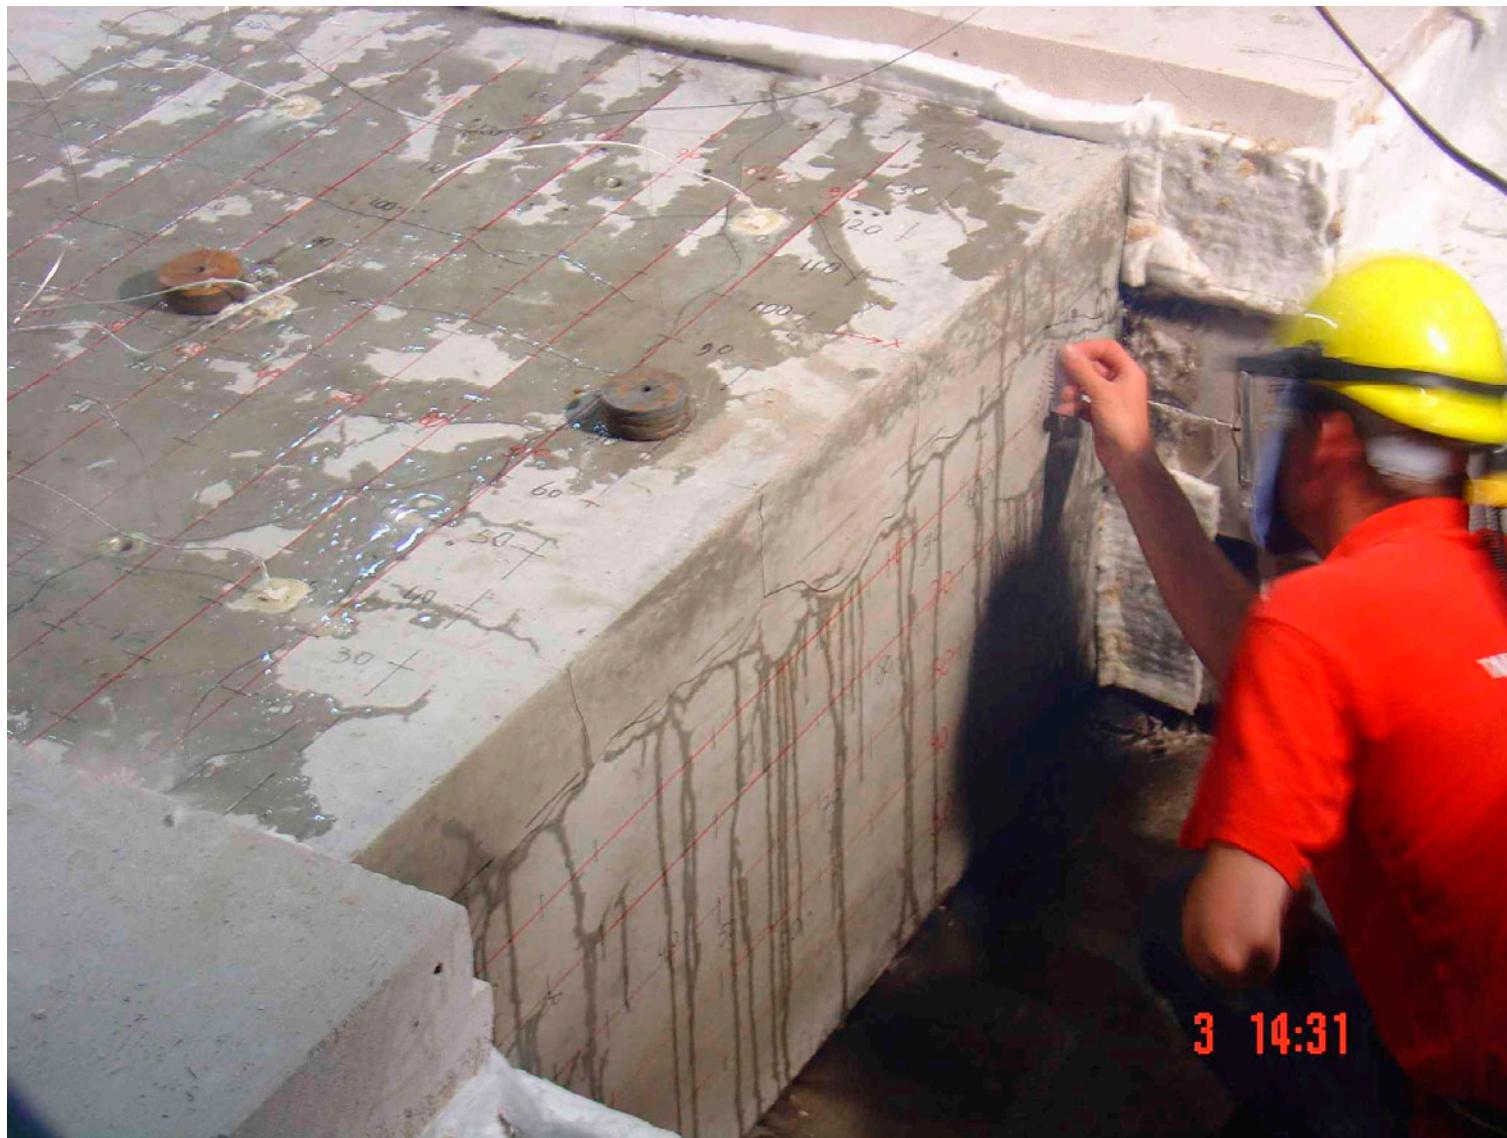
Figure F9 Element 2 after 20 minutes of heating
