Efectis Nederland report**2008-Efectis-R1046****Investigation of concrete cracking due to fire in
scaled immersed tunnel elements**

Date April 2009

An investigation of fire in immersed scaled tunnel elements.

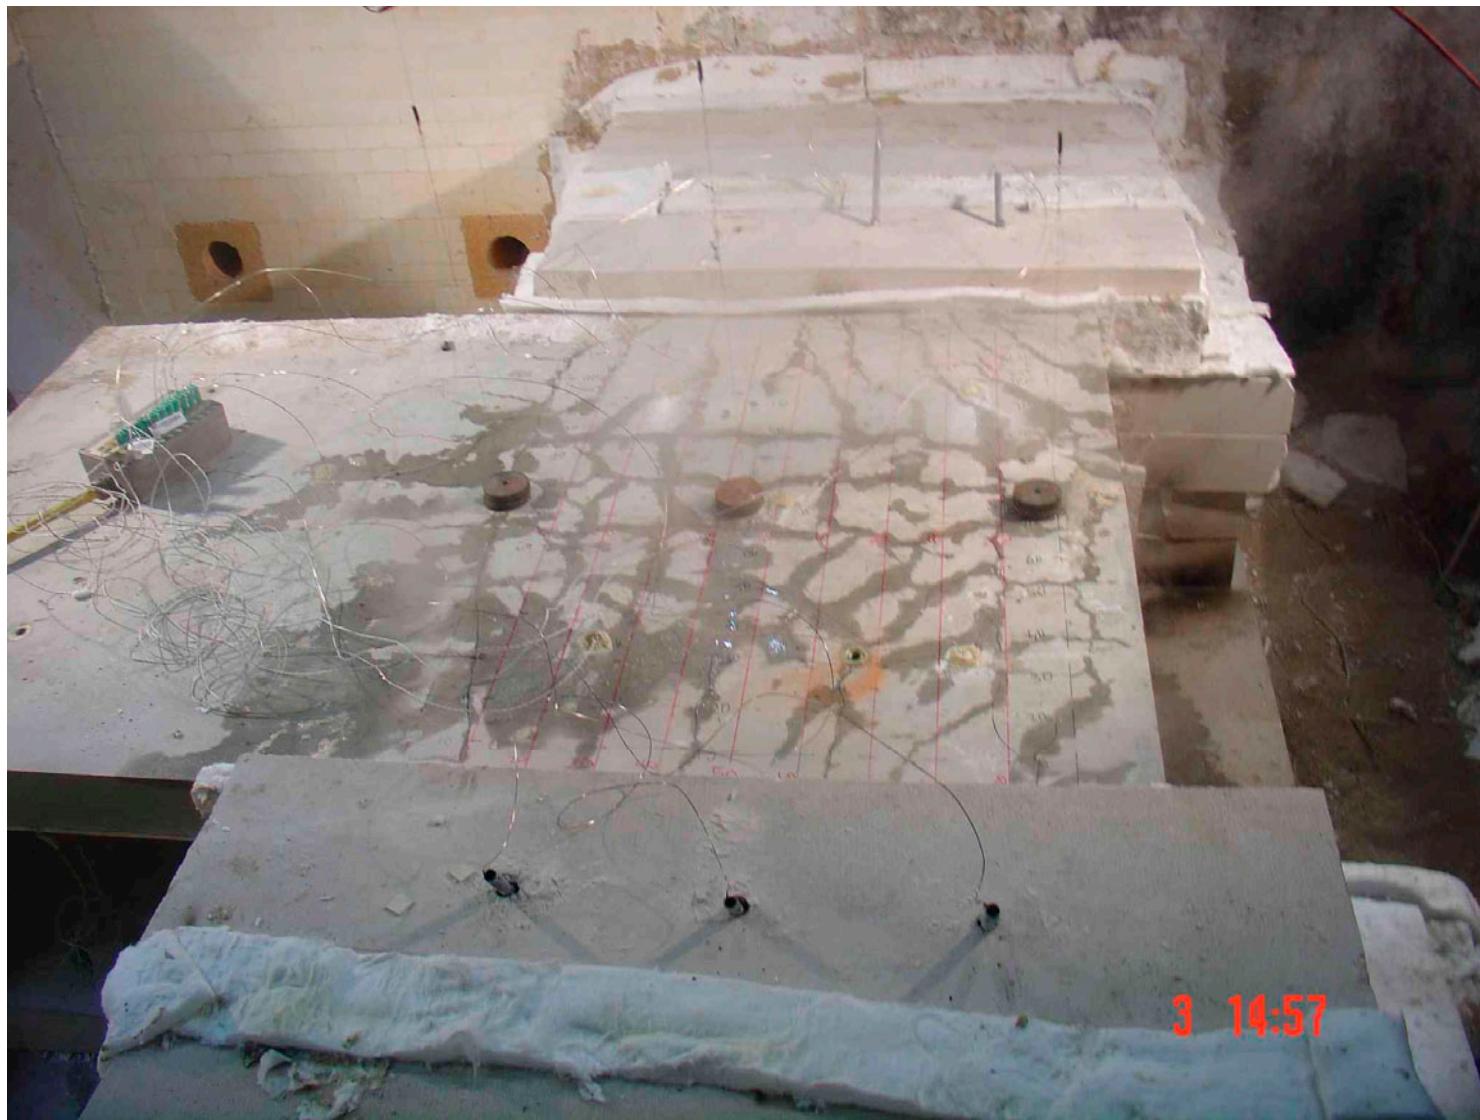
Figure F10 Element 2, 8 minutes after the fire test. The cracking pattern is clearly visible

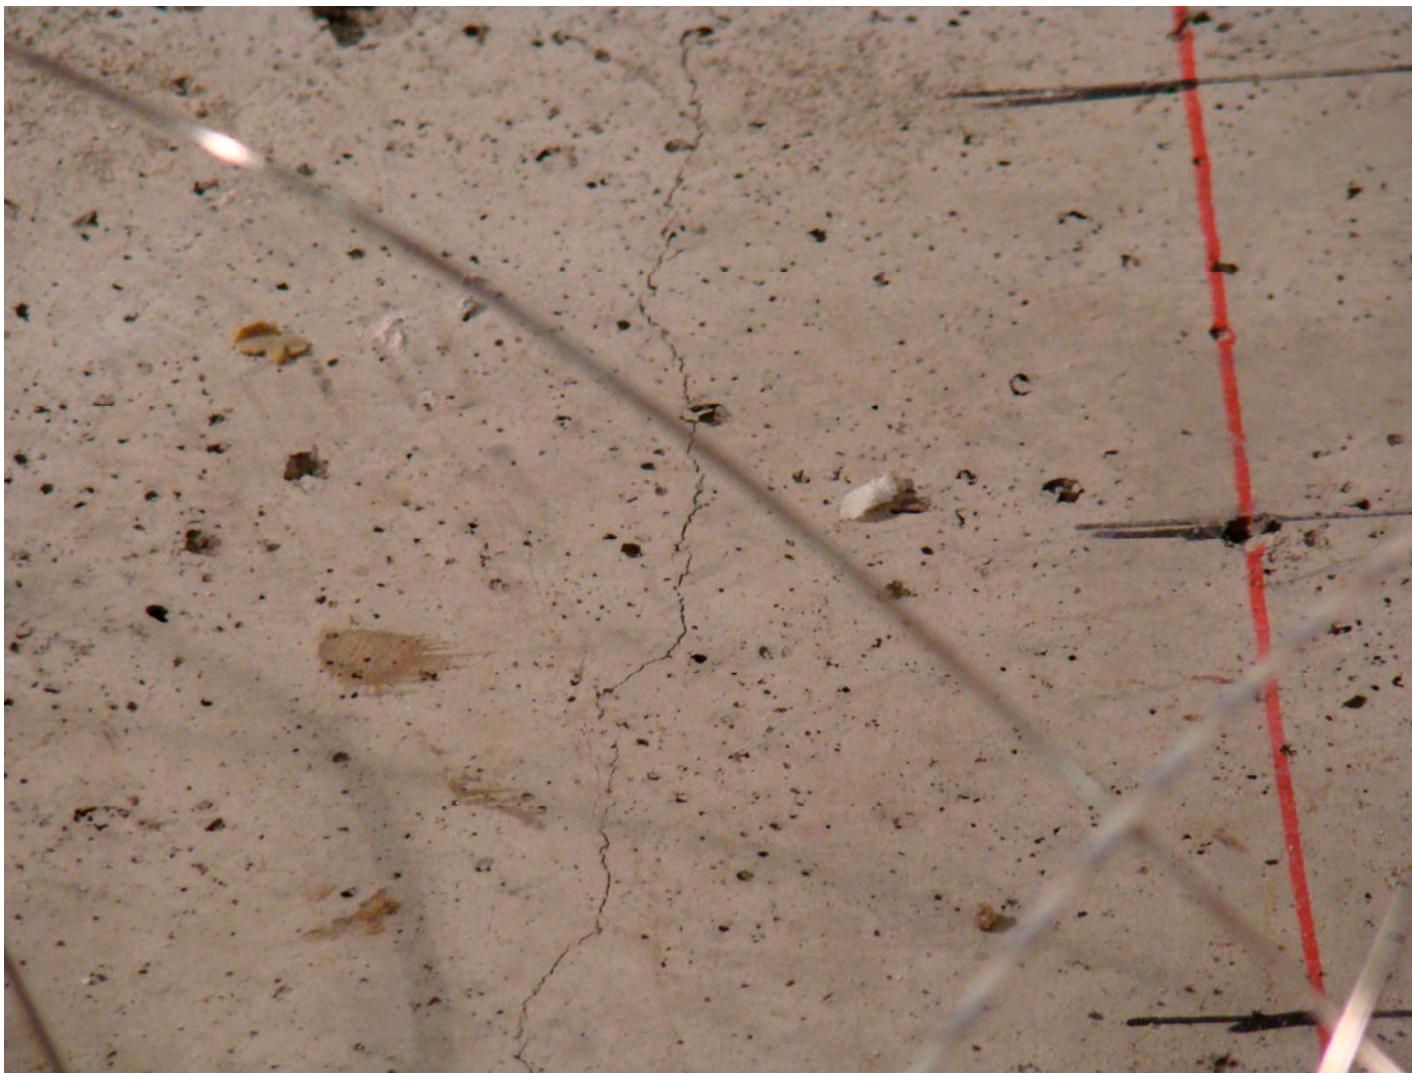
Figure I5 Element 7 after 14 minutes of heating, detail of the crack above the middle wall

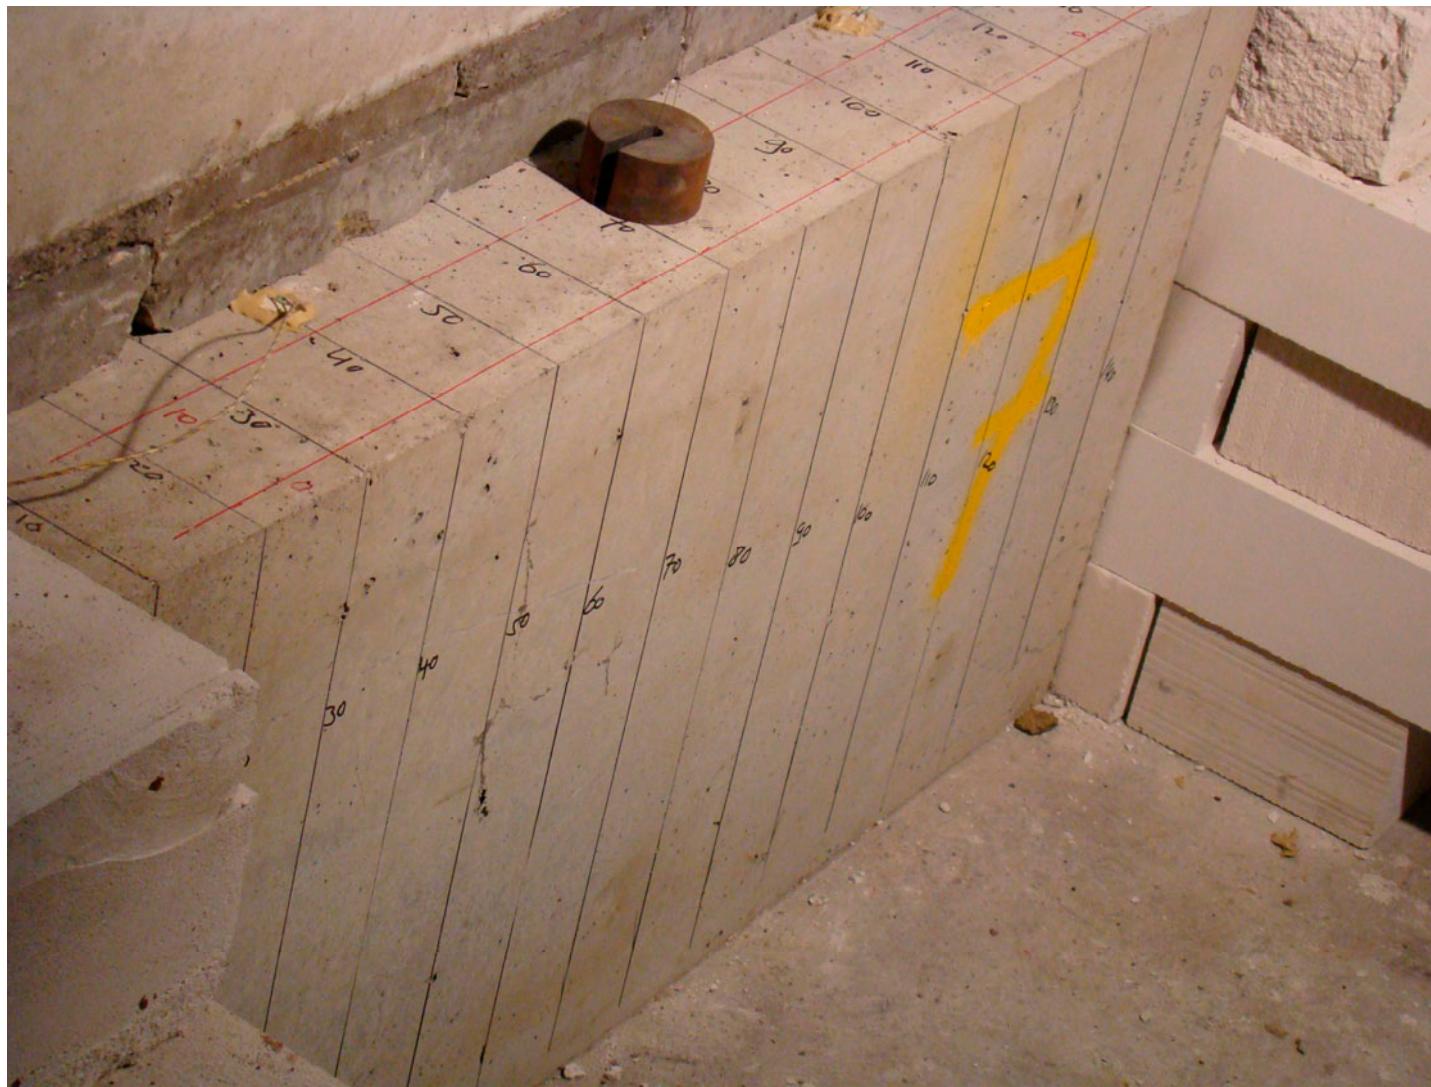
Figure I6 Element 7 after 35 minutes of heating, a view on the side surface
