Efectis Nederland report**2008-Efectis-R1046****Investigation of concrete cracking due to fire in
scaled immersed tunnel elements**

Date April 2009

An investigation of fire in immersed scaled tunnel elements.

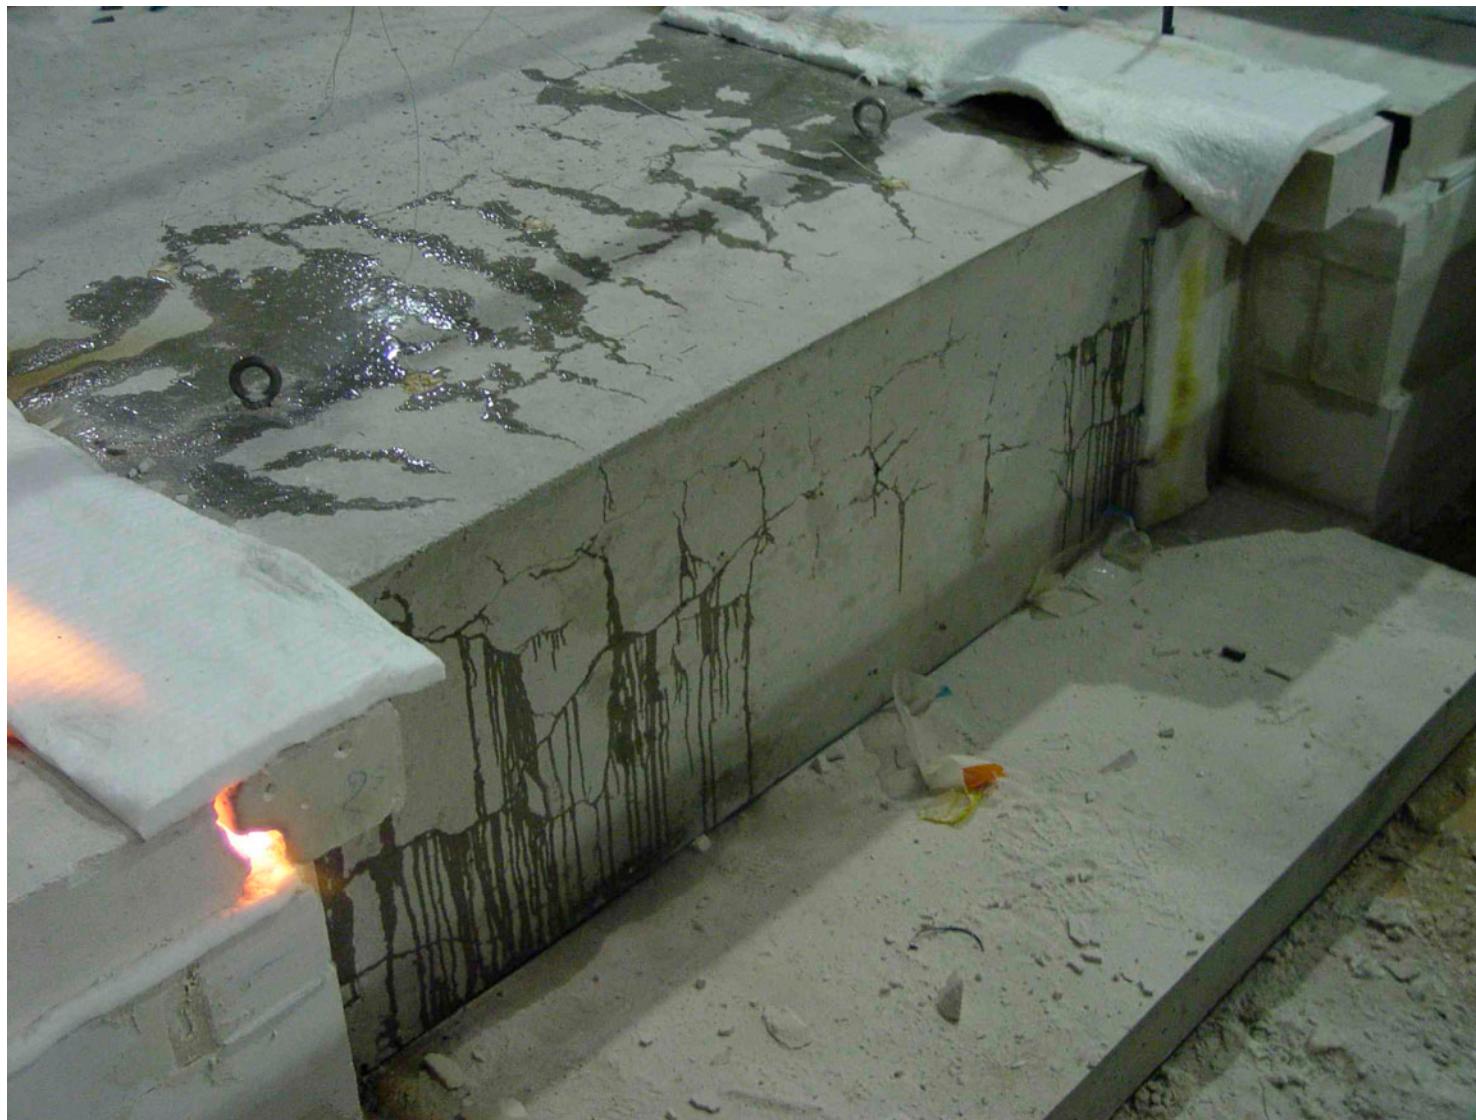
Figure A4 Element 0 after 13 minutes of heating

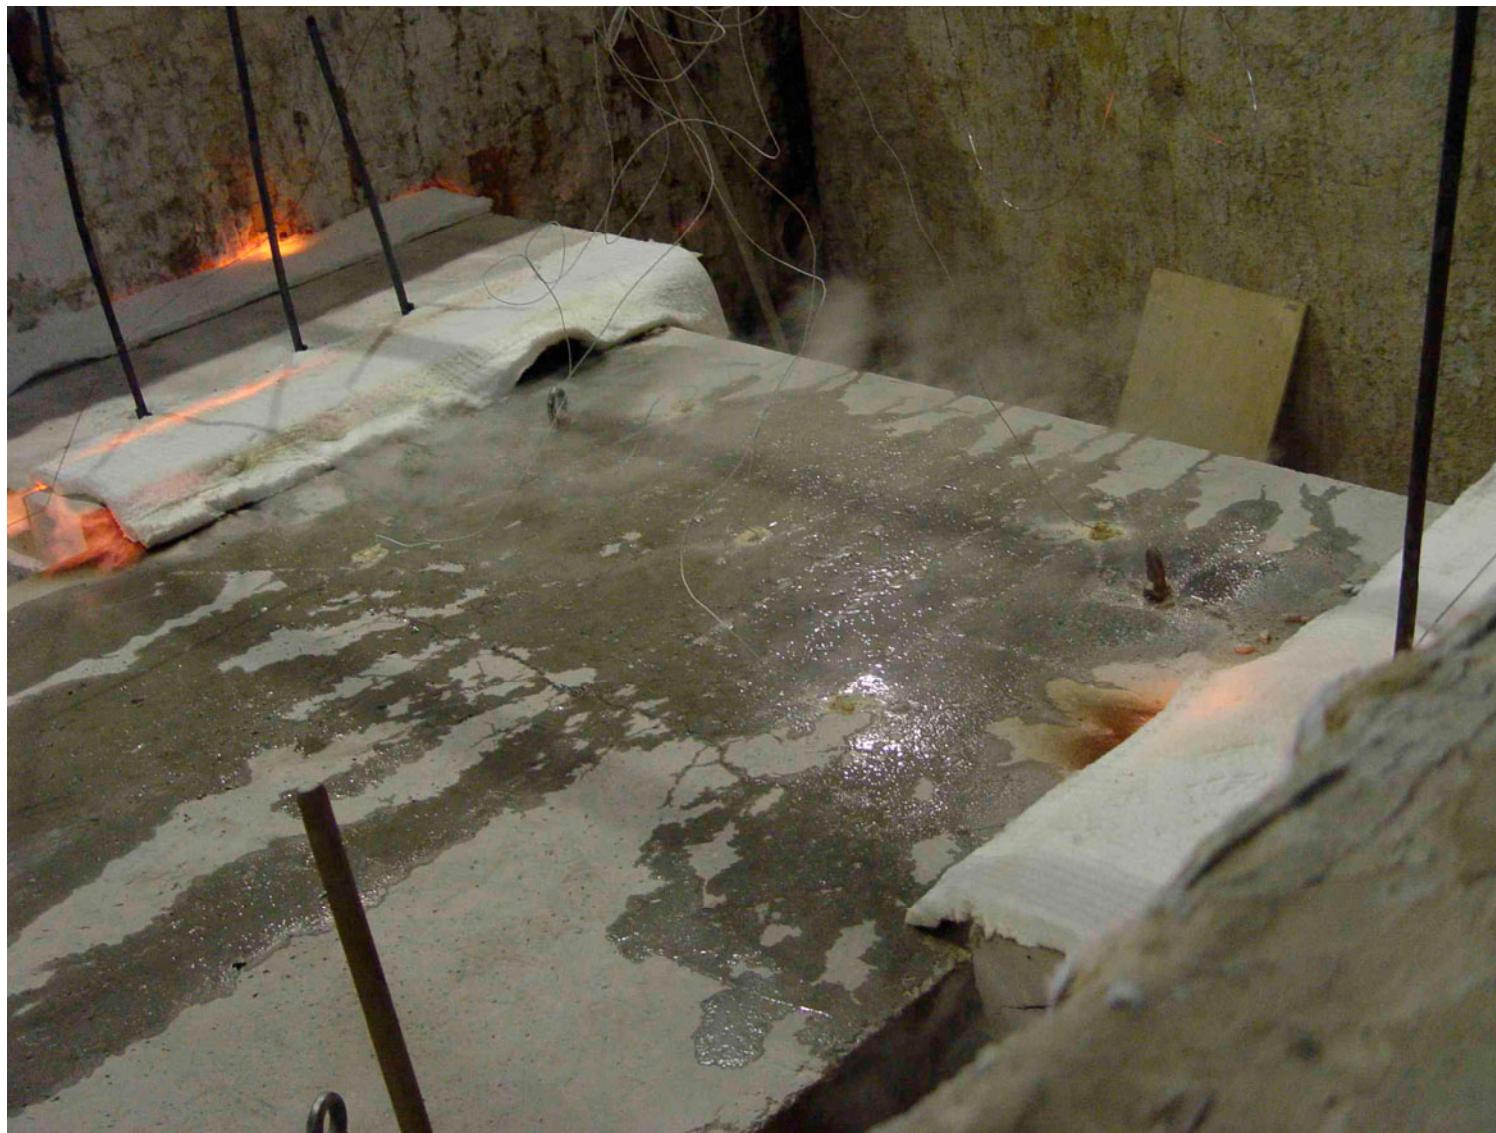
Figure A6 Element 0 after 29 minutes of heating

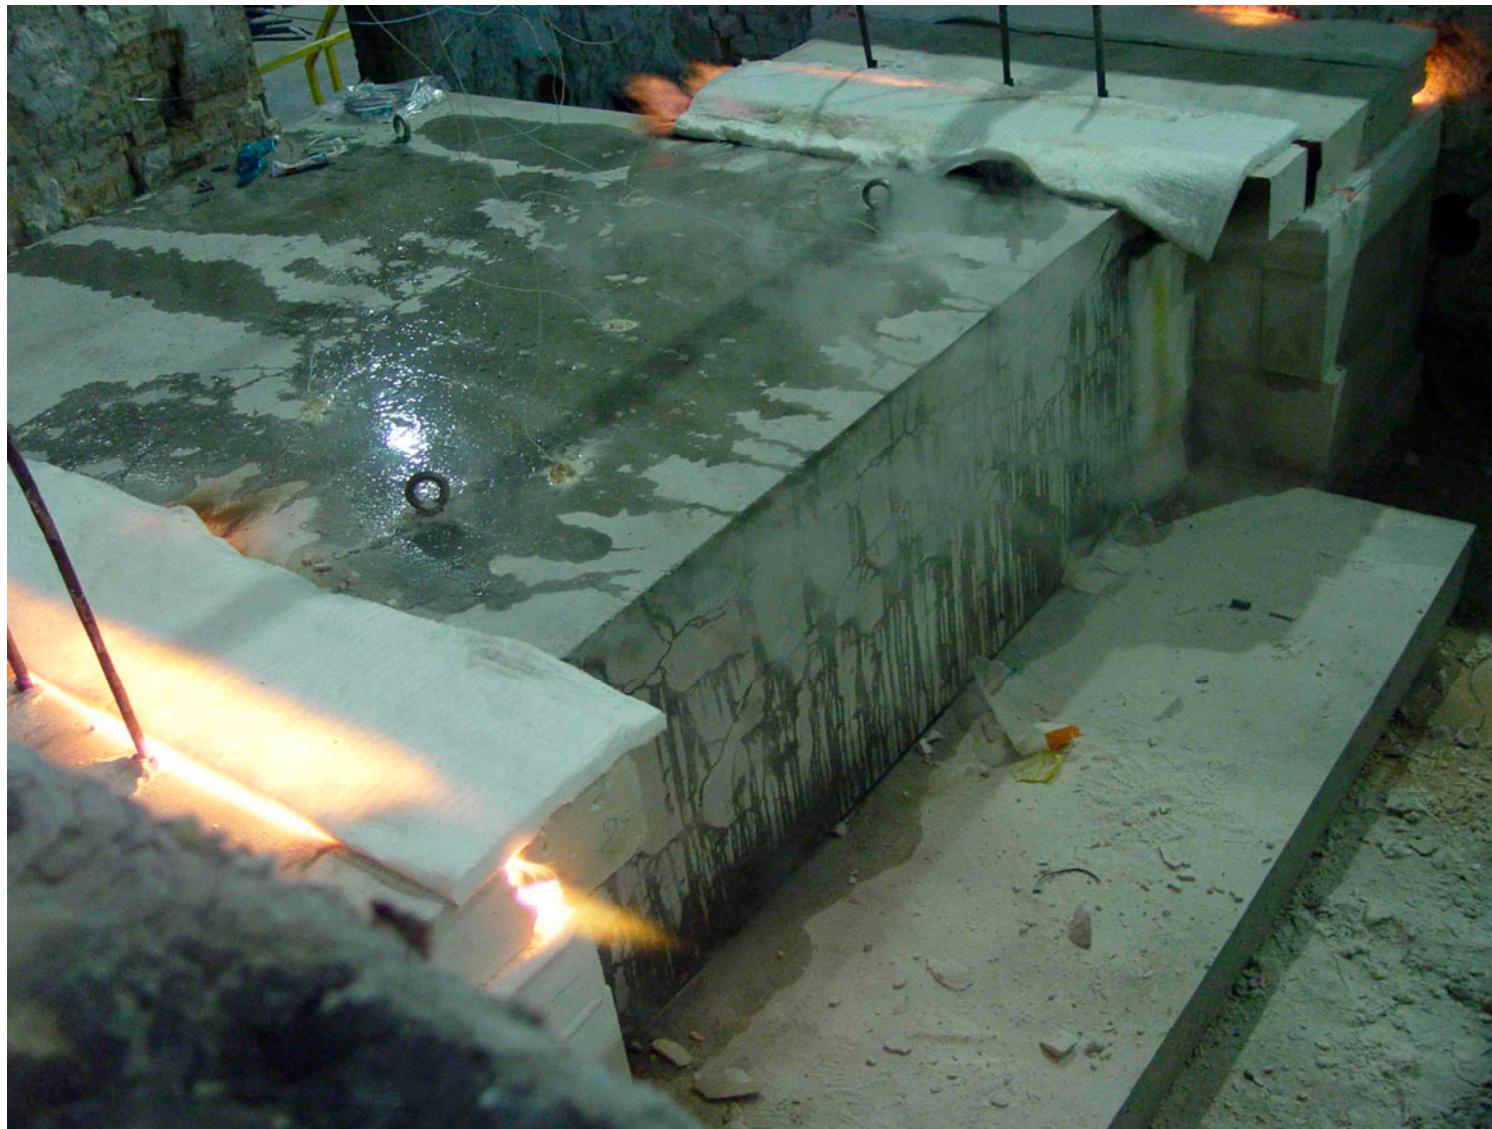
Figure A7 Element 0 after 29 minutes of heating

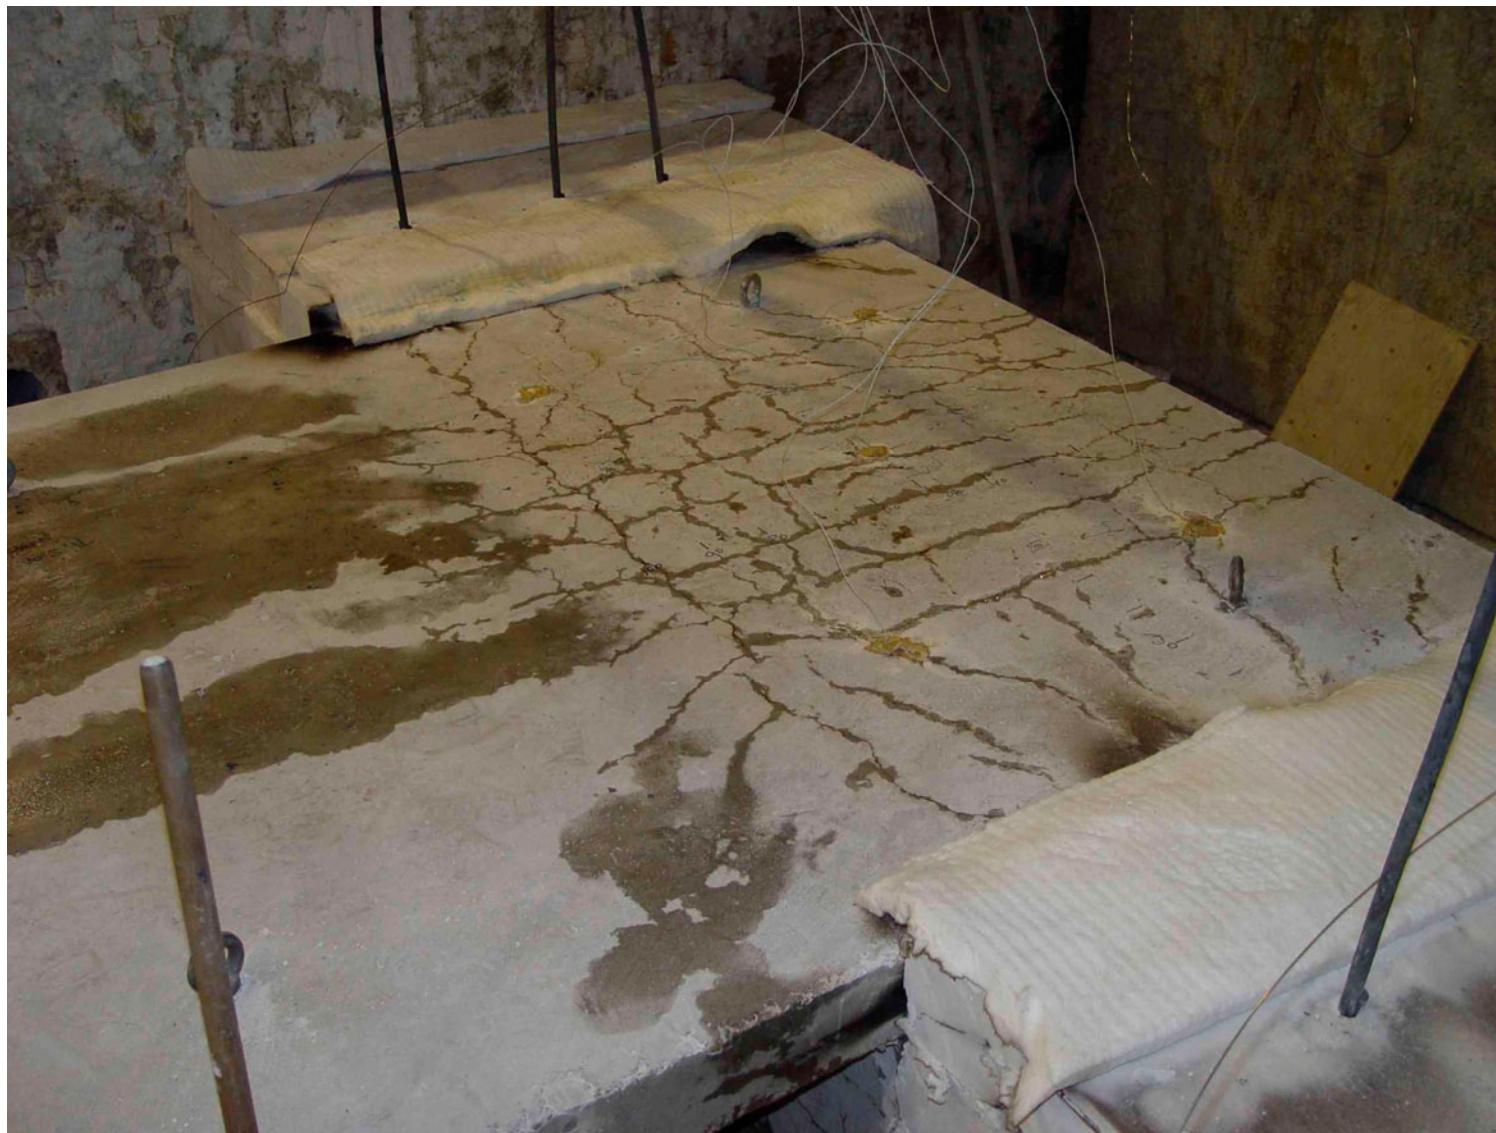
Figure A8 Element 0 after 56 minutes of heating

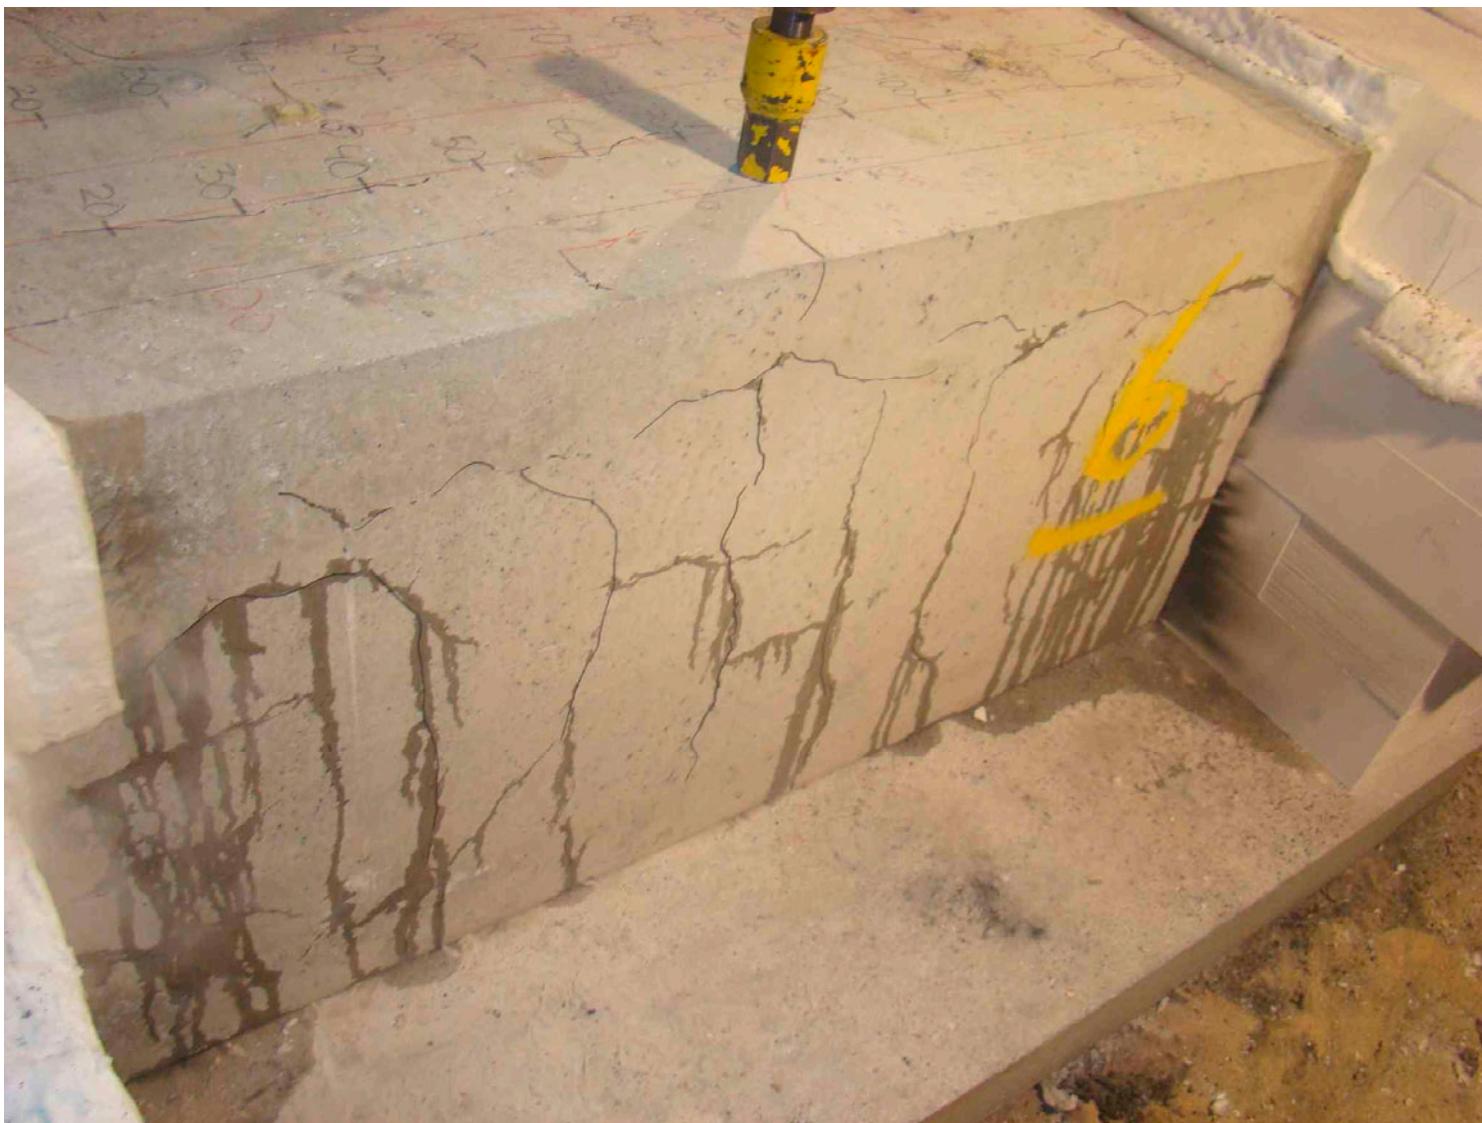
Figure B15 Element 6 after 27 minutes of heating

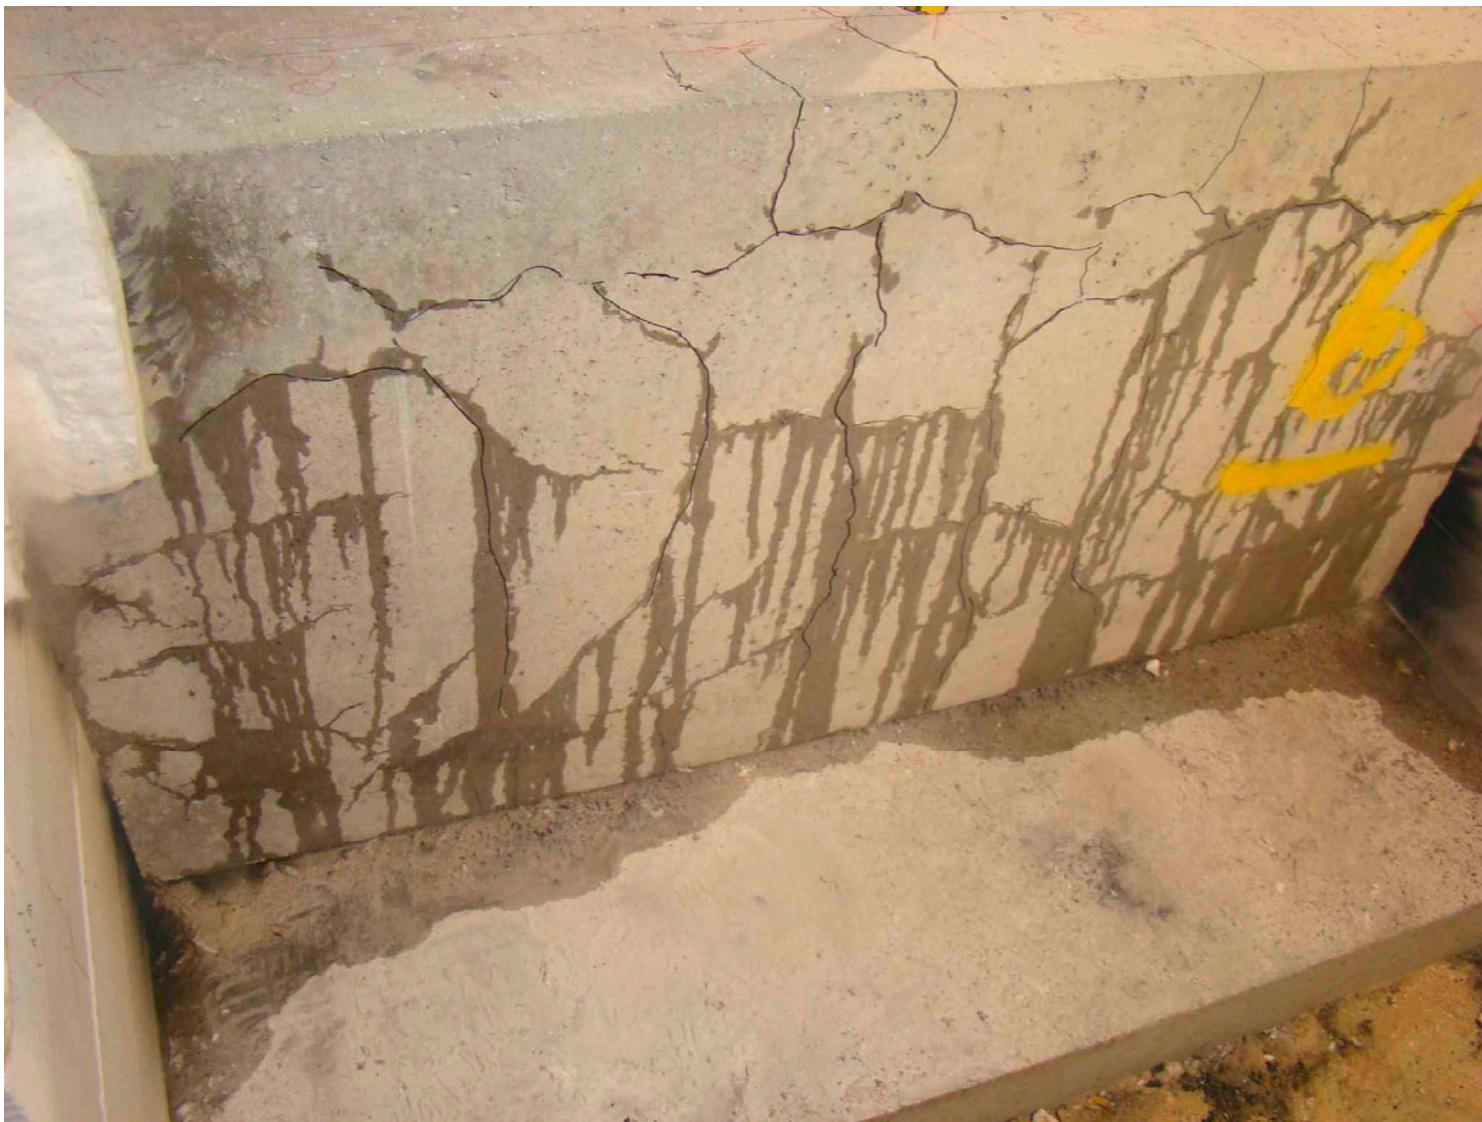
Figure B16 Element 6 after 40 minutes of heating

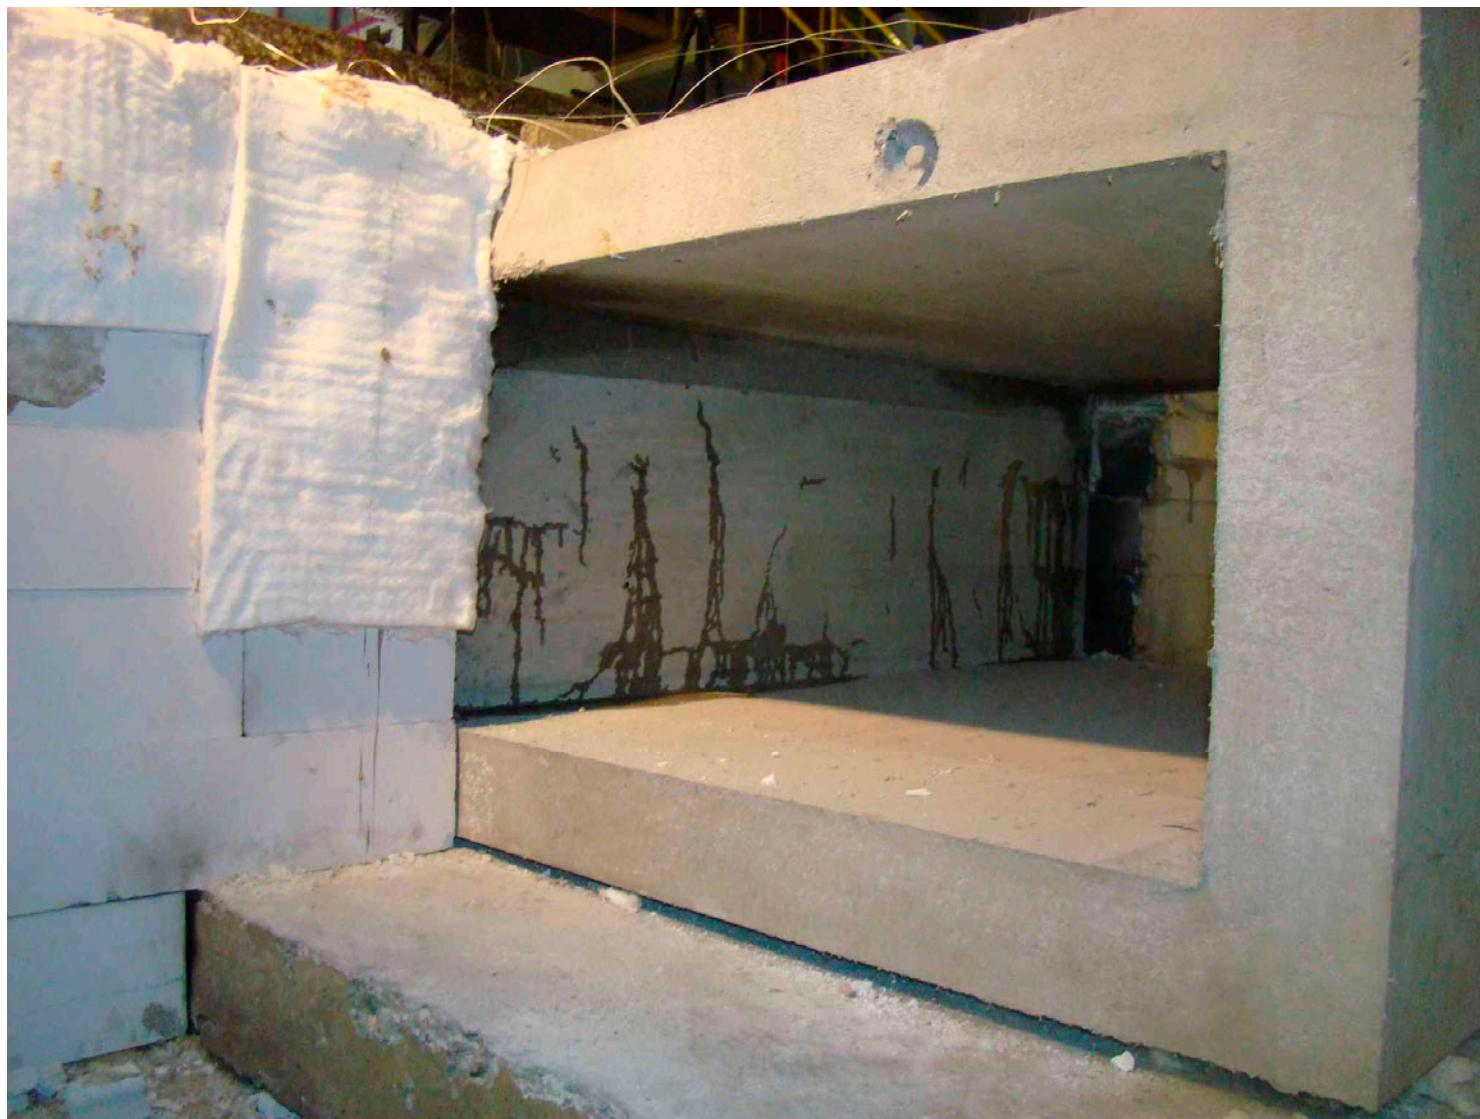
Figure C11 Element 10 after 20 minutes of heating, a view on the non heated tube. Note that the bottom of the element is lifted from the floor

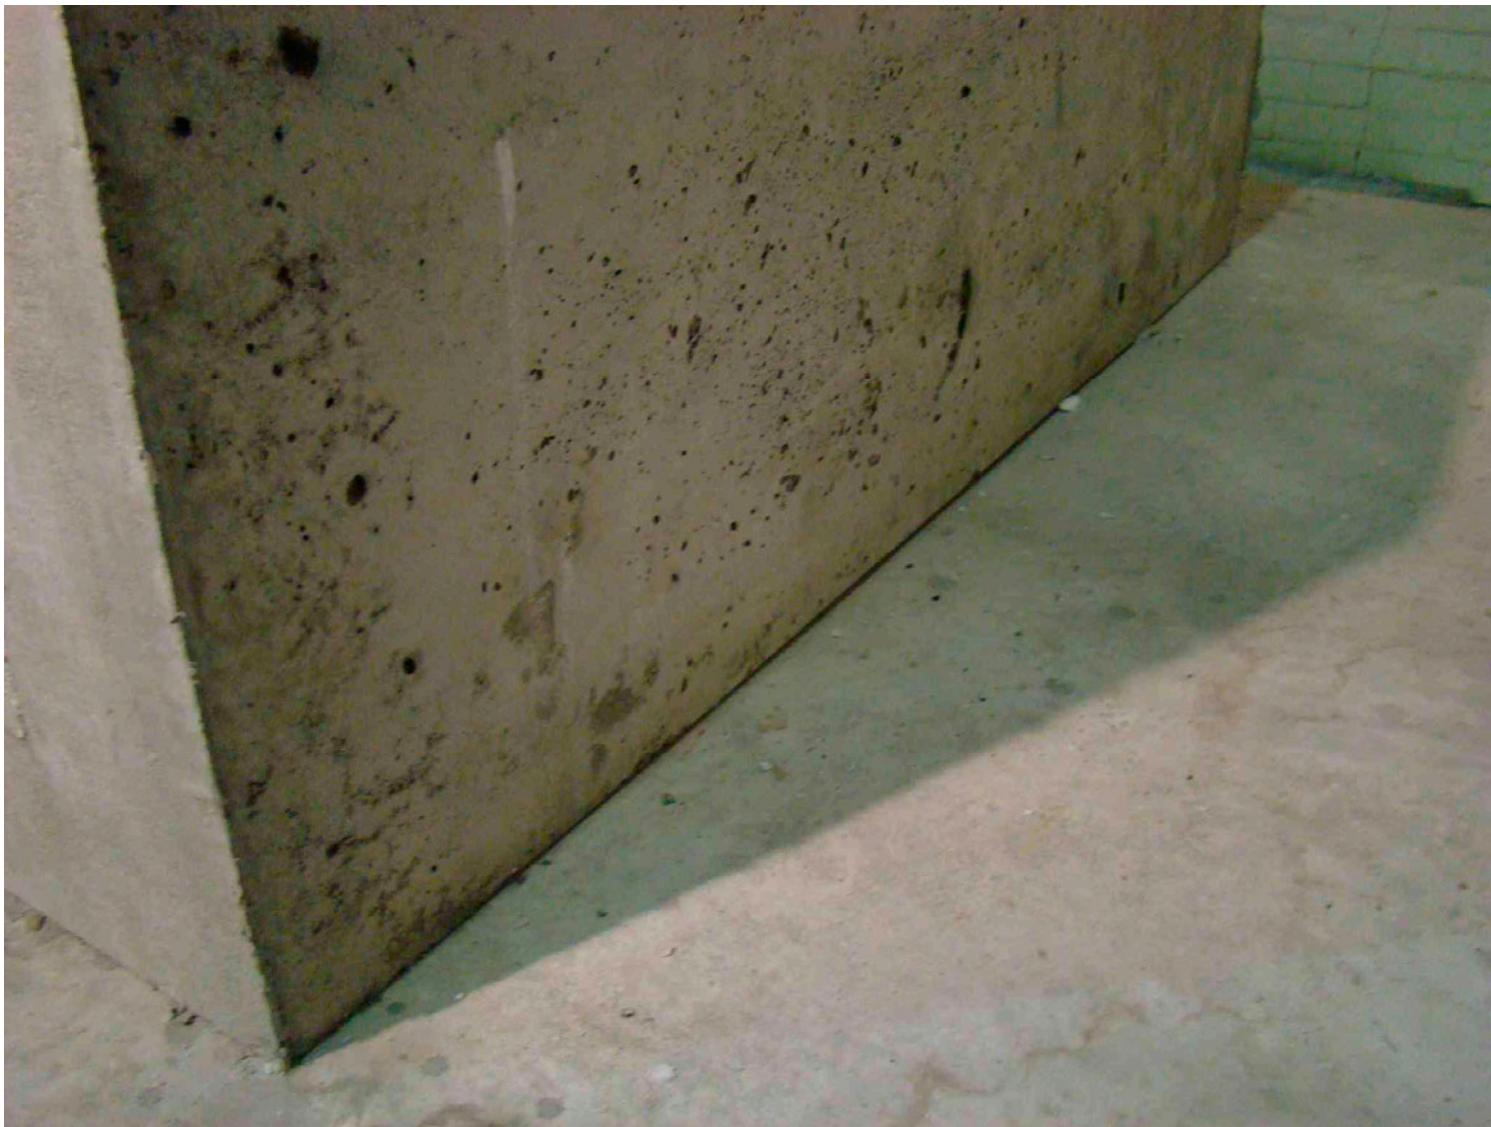
Figure D11 Element 8 after 44 minutes of heating. This is side surface of the non heated tube which is lifted approximately 10 mm

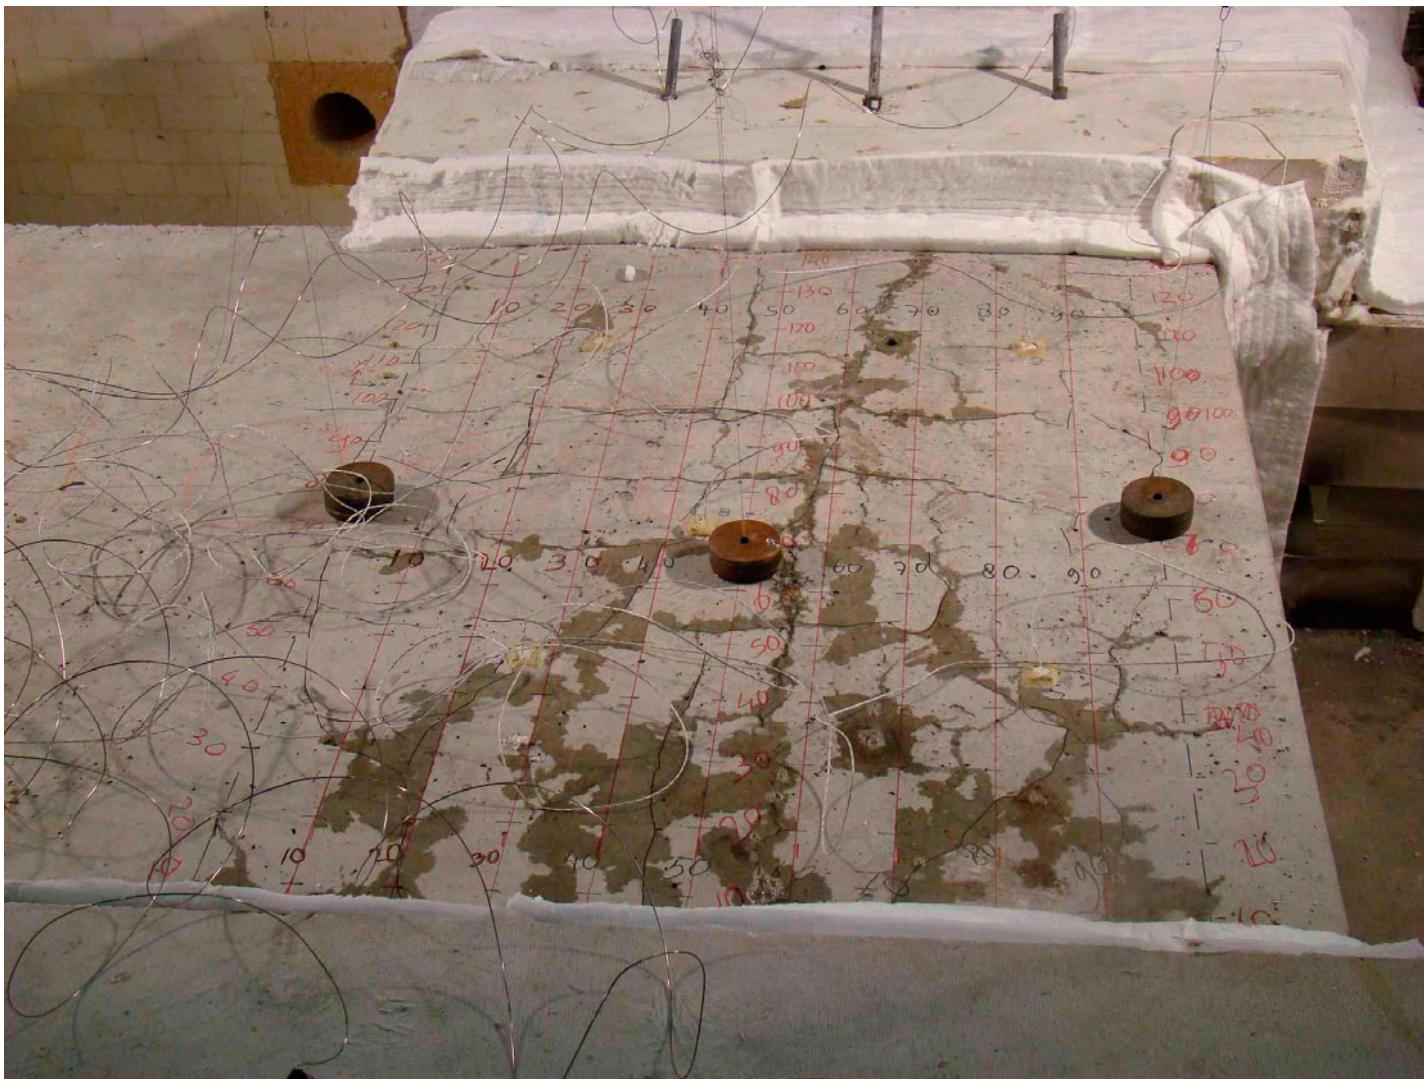
Figure G10 Element 9 after 45 minutes of heating

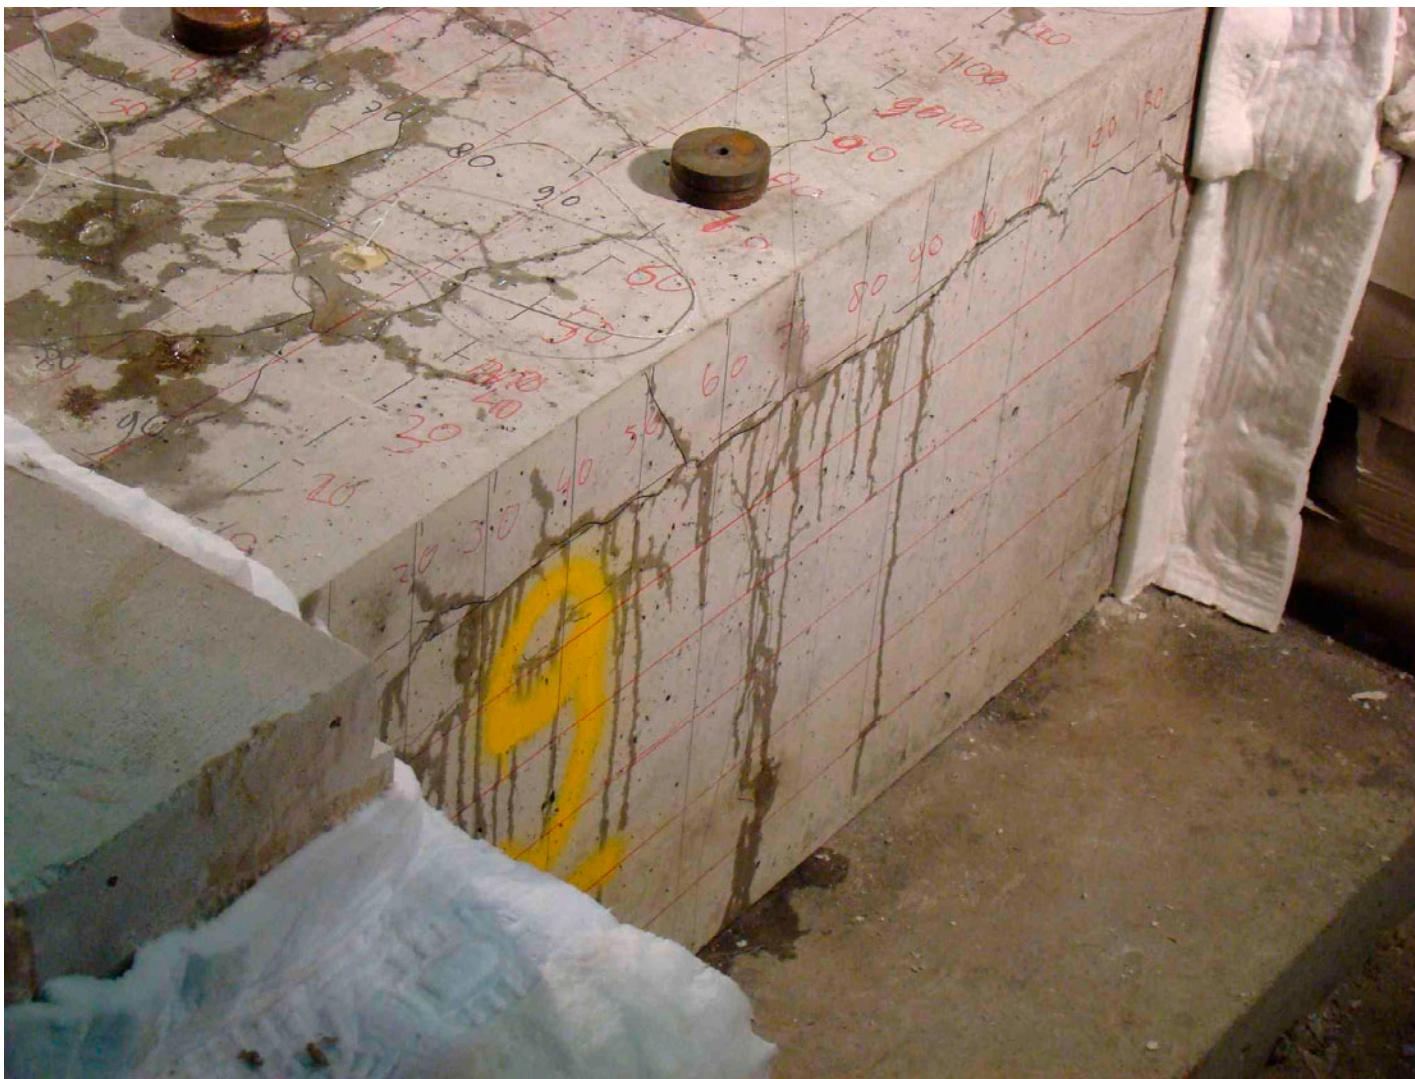
Figure G11 Element 9 after 48 minutes of heating

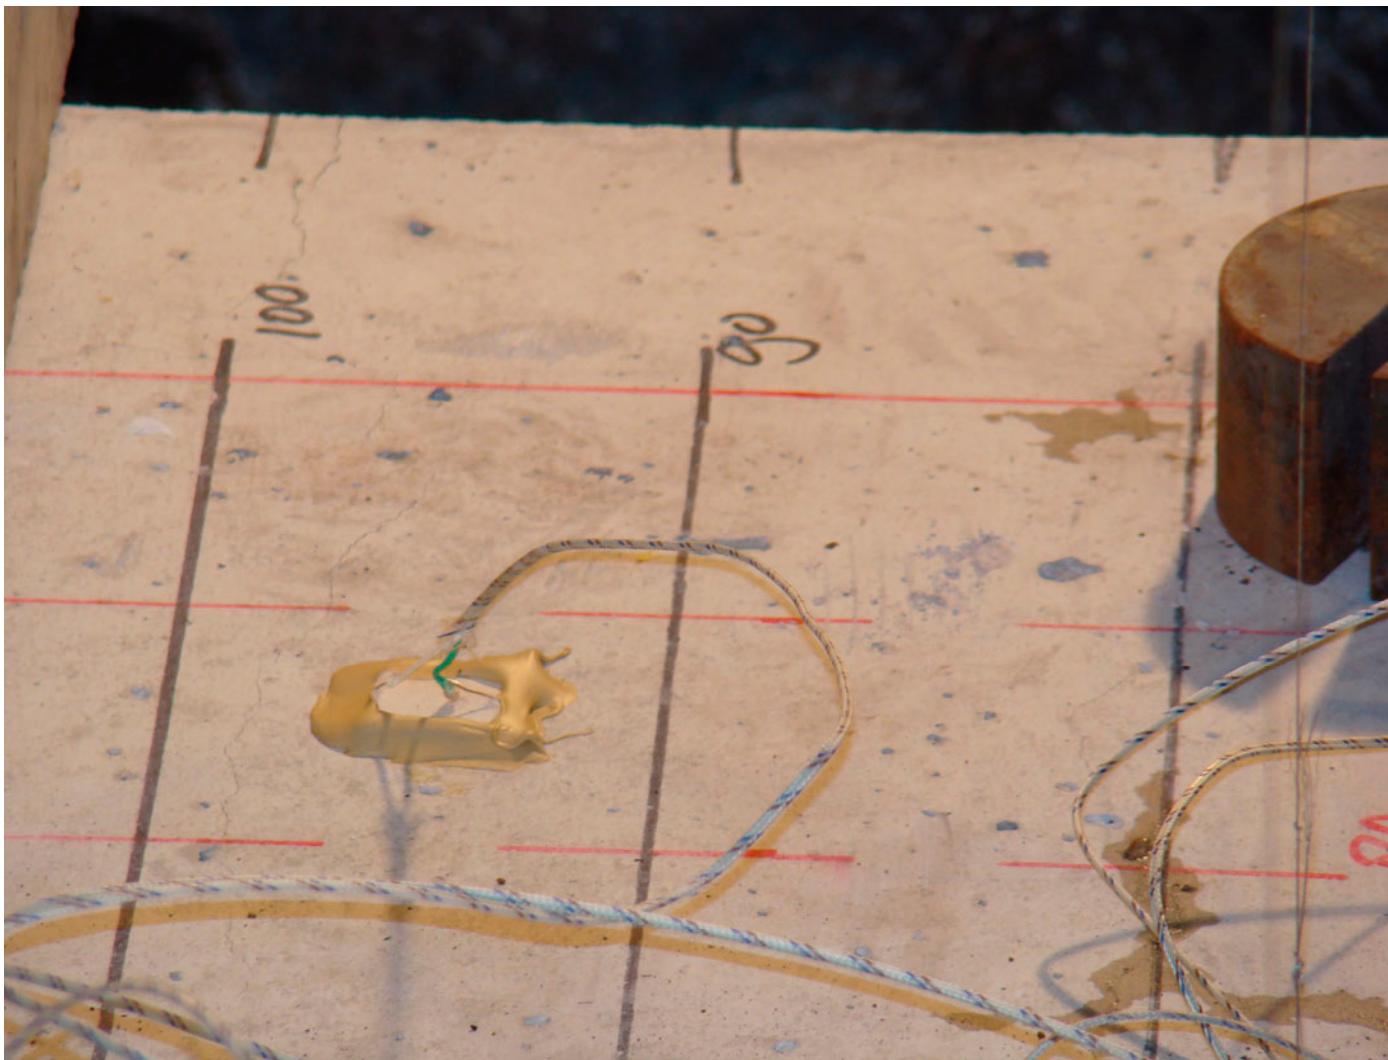
Figure H5 Element 5 after approximately 40 minutes of heating. Detail photograph of the region X = 75-100, Y = 90-105

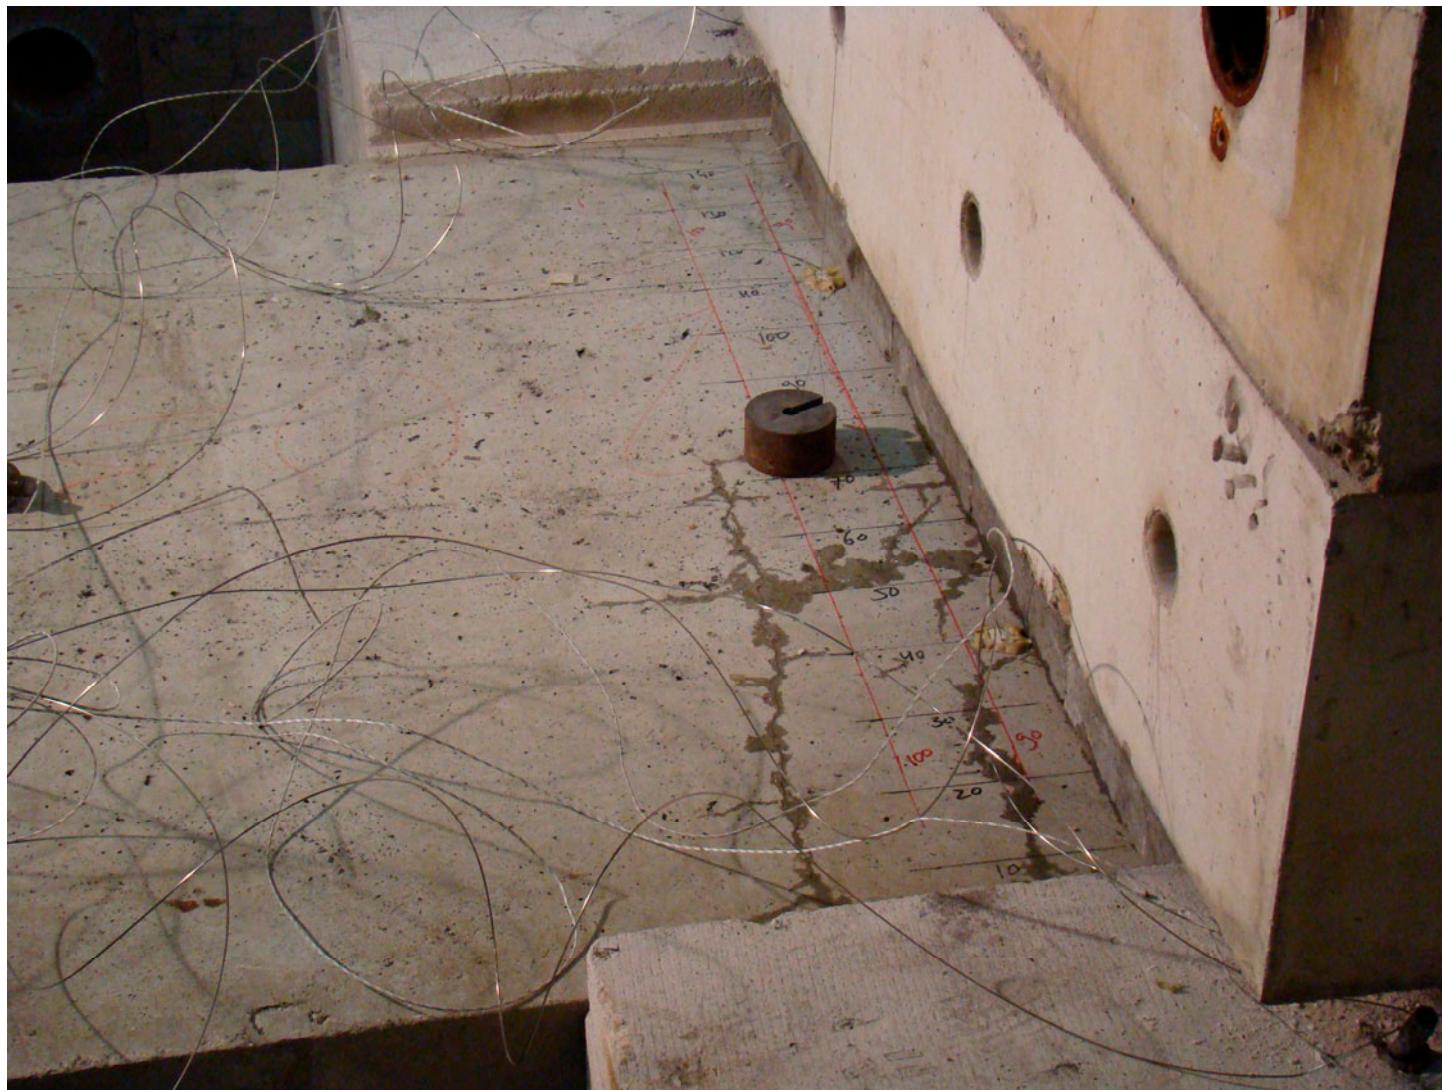
Figure I7 Element 7 after 50 minutes of heating, a view on the middle wall

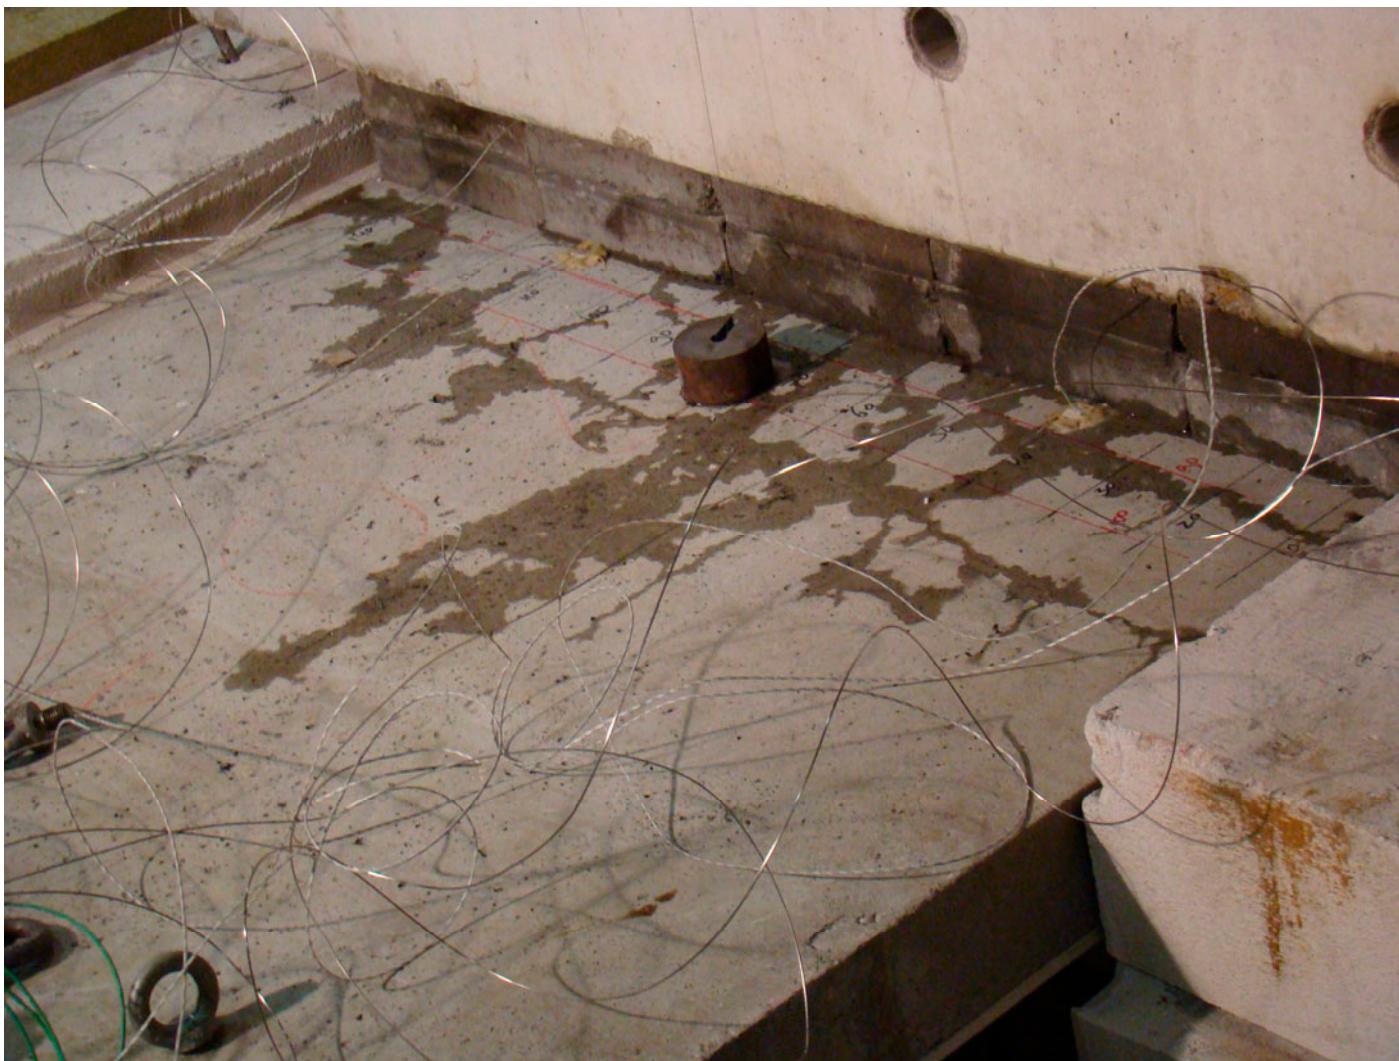
Figure I8 Element 7 after 75 minutes of heating
